18201

August 20, 2018

RE: WHITE WATERS LTD – 893 KAKAPO ROAD TE ANAU
MEGAPOND STRUCTURAL REVIEW

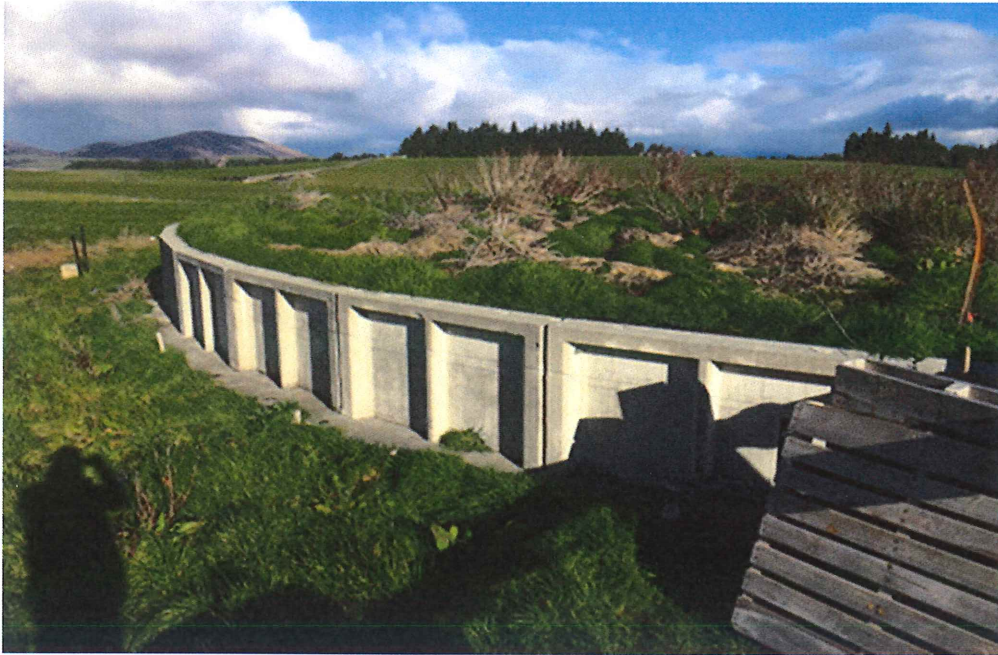
View of typical pond construction pond looking towards South East

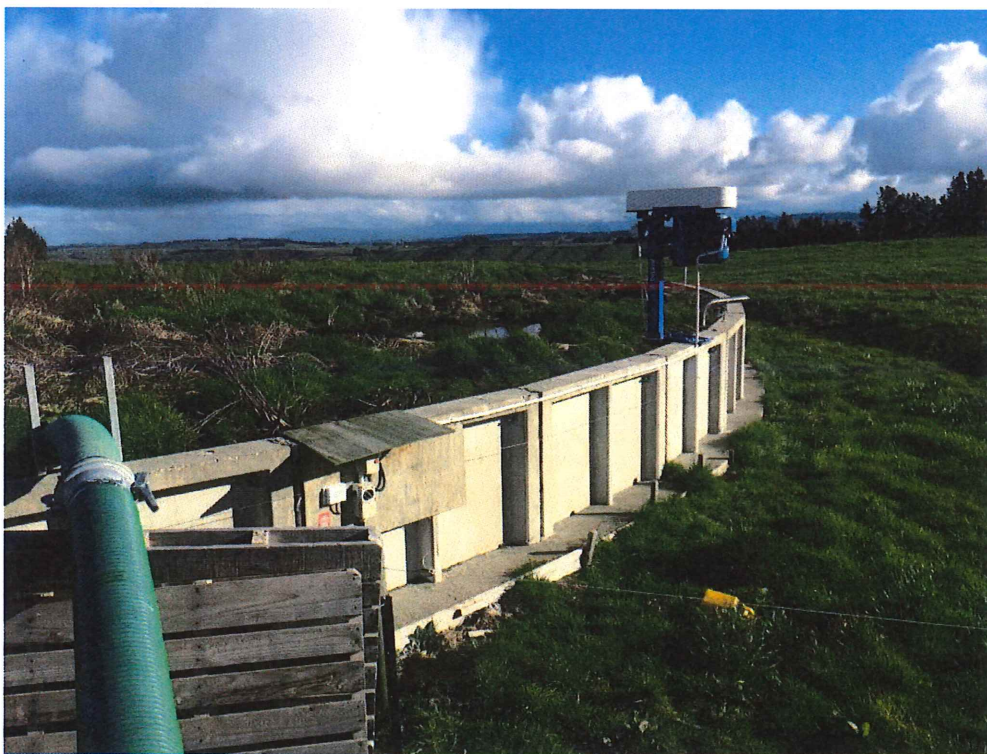
Similar view looking towards the North west

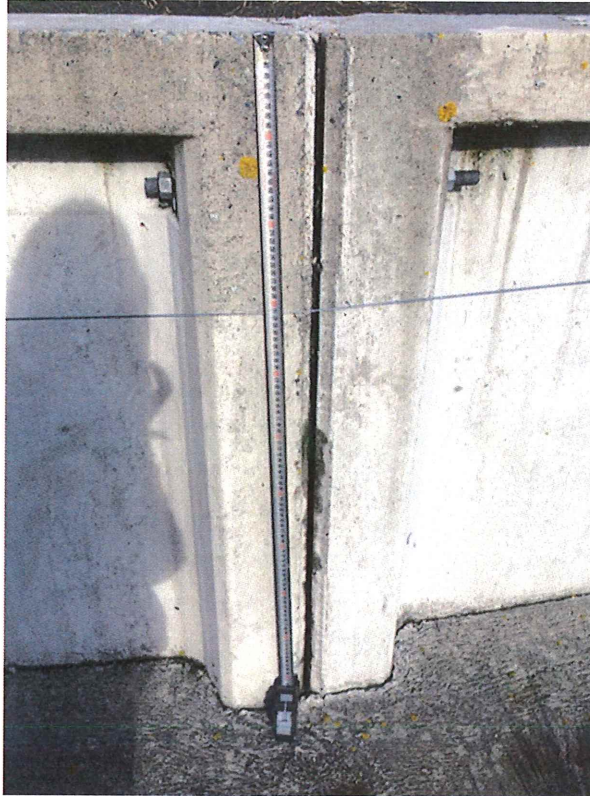
Our observation of each and every panel showed that only one panel rib had a fine hairline shrinkage crack at the top corner near the tie bolt. No other visible cracking was observed elsewhere either around these top tie bolts at the supporting ribs or anywhere within the flat panel areas of the other panels. (refer appended photos).

These areas around the top bolts are the most vulnerable highly stressed areas and the absence of any observed open movement type cracking would indicate that the concrete has not been overstressed and continues to function as designed.

View showing typical level of damp concrete below the top level observed in a few locations. Minor diagonal shrinkage crack in top right hand pier - only cracking observed

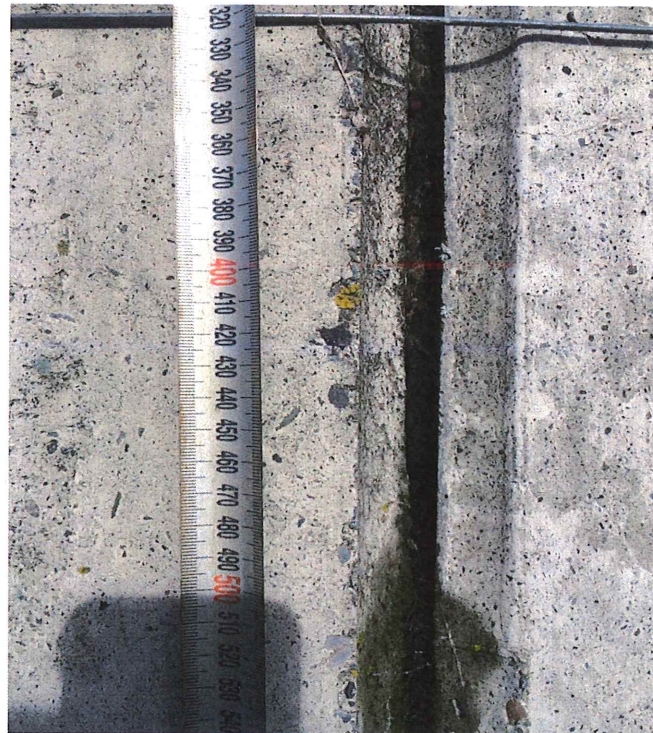
Our initial observation is that the tank is brim full rather than at a normal maximum operating level. At the time of inspection substantial rainfall had occurred in the preceding 48 hours with 23mm of rainfall recorded at a neighbouring property. There was clear liquid, presumably rainwater, ponded on top of the effluent crust and at a couple of low points in the tank wall, was weeping over the sides. The flow was insufficient to cause ponding at ground level though. (refer to photos). The tank appears to have a slight low spot to the west quadrant and was probably constructed that way. This has no effect on the structure's integrity. Many joints in the lower section of the wall were observed to be damp from minor weeping but no observable flow was

noticeable at any joint even with the excess hydraulic head presently created by the overfull pond (refer to photos).

Closeup view of level of damp concrete below top of pond.

We would however, recommend that the condition of the minor weeping of the joints is assessed further and any remedial maintenance work undertaken. The pond level initially should be pumped down to the normal operating level and the joints all inspected for any further weeping. These inspections should be undertaken during a dry period and then also after a period of rain to assess where any weeping may be initiated from i.e. from the interior joint or simply from water entering through the vertical cracks in the grout of the panel to panel shear key. It is suspected that many of the weeping areas will likely cease with the reduced hydraulic gradient. It is unknown what the likely permeability of the particular mastic sealant is under an elevated hydraulic head. The storage level should be reduced further to the minimum and all the interior joints inspected for any damage and remedial work undertaken as necessary. Again, the inspections should be during a dry period and also after rain. To achieve a long term service life from the pond we would also recommend that the top of the panel to panel grout joints are fully cleaned out and further grouted with a highly fluid grout. This will seal the present cracks and also those voids that are not completely full to the walls top surface.

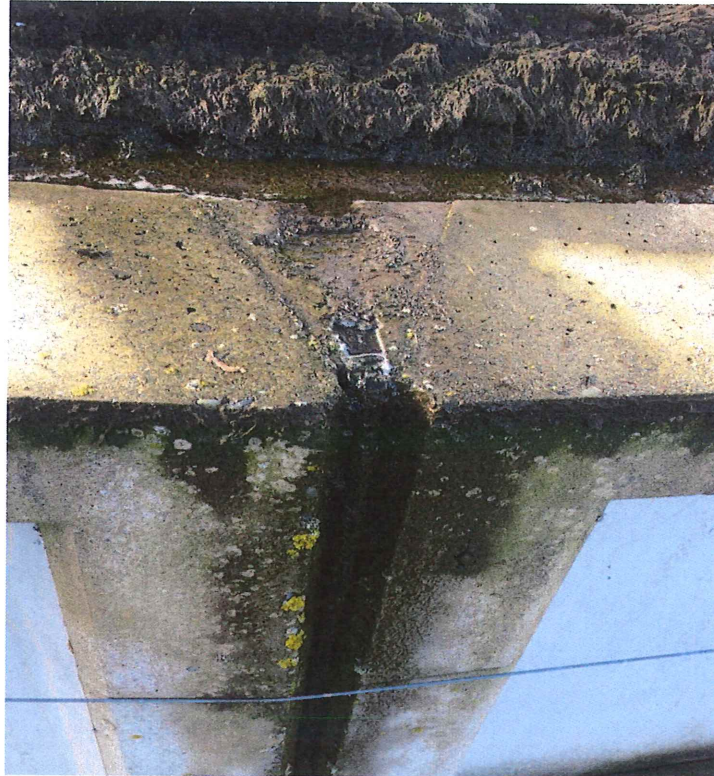
Typical overflow down joint from overfull pond at low side of the pond. Grout infill and sealant are all in good condition.

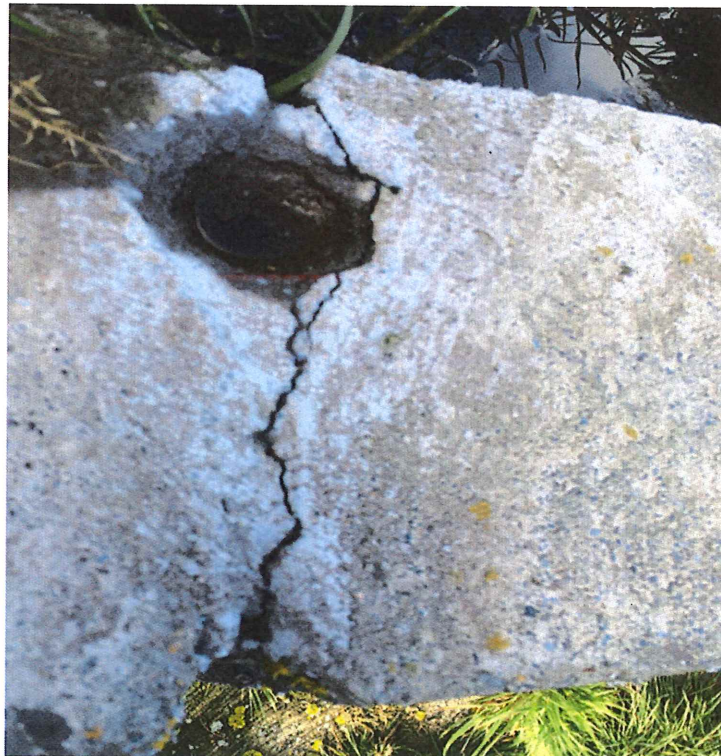
Many of the post grouted panel to panel shear key joints exhibit vertical cracks within the grouted joint, which is a function of the high strength grout used and shrinkage as it cured. This shrinkage would most likely have occurred shortly after construction. It is considered that the rainwater could be tracking down these joints and weeping through the external mastic. During extended cold winter periods trapped water behind the outer sealant may become frozen, especially on the south side of the tank, resulting in expansion forces that could ultimately break the concrete to sealant bond and ultimately push the sealant out. The grouted joints however still continue to transfer shear with the ring beams in place but should be regrouted and the tops sealed.

View of shrinkage crack in grout through top of the panel and low level of grout in shear key. Several areas like this noted, which require cleaned out and additional grout.

- 1) The drainage swale around the pond should be established to improve drainage within the next six months.
- 2) The external panel joint mastic should be inspected for weeping before rain and after rain when the pond is next pumped down to normal freeboard levels.
- 3) Within the next 12 months the pond level should be lowered as much as practical and the internal mastic checked for continuity and soundness.
- 4) Within the next 6 months after the summer months and before the next winter period, seal the shrinkage cracks in the grout key and surface depressions with a highly fluid grout.

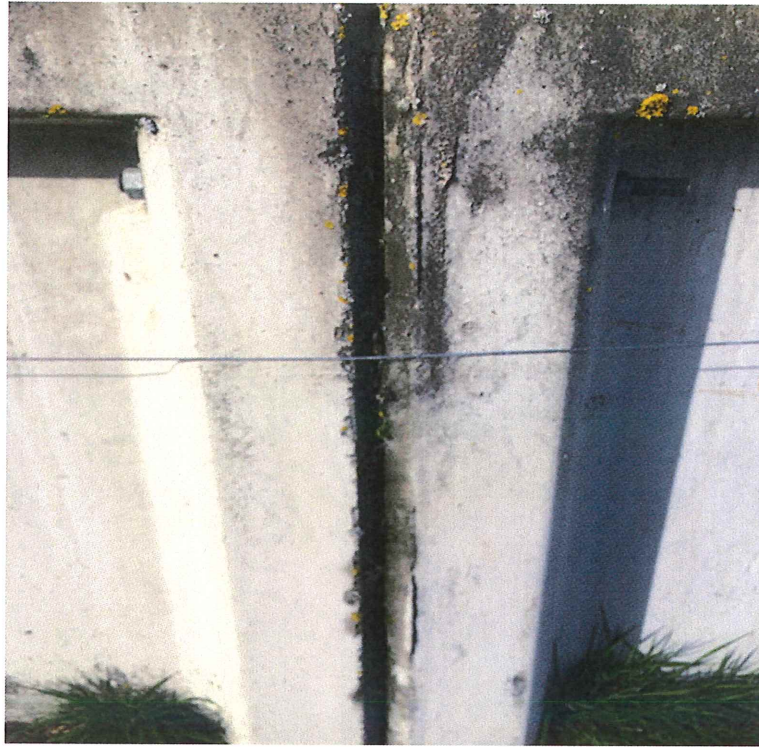
The exterior mastic sealant was observed to be intact and in good condition over its full observable length. Only a small section of the internal mastic sealant was visible at the top but is assumed to have been installed correctly at the time and continues to function effectively. The tank construction was independently overviewed and a construction producer statement PS4 issued for the tank by OPUS Consultants verifying to that effect.

External view of previous top joint showing sealant in good condition and minor damp concrete at the lower level.

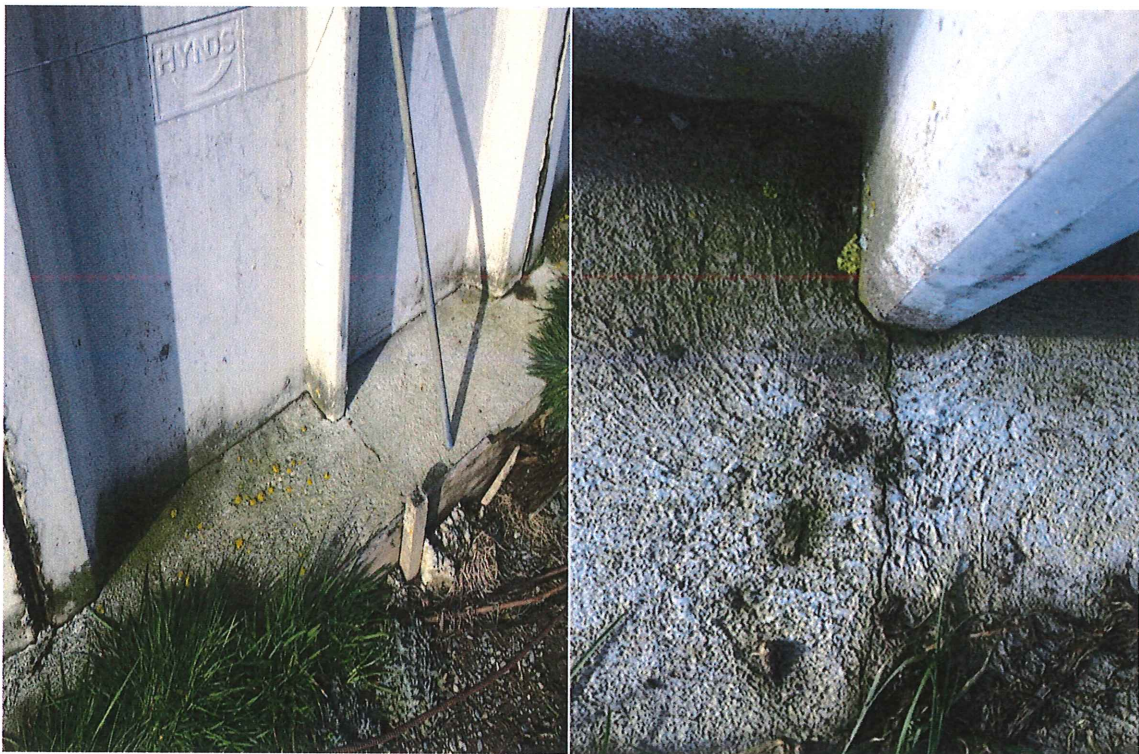
Shrinkage cracking was observed in the ground level ring beam generally at each of the smaller intermediate ribs where these would tend to initiate cracking. (refer to attached photos). This form of cracking is to be expected in a small beam cross-section, which is lightly reinforced and most probably poured as a continuous pour during construction. The ground level ring beam has settled slightly also as the perimeter external fill has consolidated slightly over time, which could have also contributed to these observed cracks. Structurally, this is not considered detrimental to the tanks performance at this time provided the fill level remains consolidated at its present level. Controlling the site drainage around the tank would therefore be beneficial to prevent the fill material being saturated then drying out during drier weather, creating a possible shrink / swell effect that could cause further settlement.

Typical view of ground level ring beam and close up view in RH photo of typical shrinkage crack initiated at smaller centre panel rib.

Creating a drainage swale around the tank perimeter at the toe of the excavated bank and directed downslope would be very beneficial in maintaining drier fill. Saturated fill to the perimeter of the tank while being emptied could also impose significant loads to the walls and the floor of the tank.
