**BEFORE THE ENVIRONMENT COURT  
I MUA I TE KOOTI TAIAO O AOTEAROA**

**STATEMENT OF EVIDENCE OF NICHOLAS WARD ON BEHALF OF THE  
SOUTHLAND REGIONAL COUNCIL  
14 December 2018**

- 11 I have been asked by the Council to provide evidence in relation to estuarine and lake health in Southland. My evidence addresses:
- (a) Estuarine health in Southland including current state, trends, and methodology; and
  - (b) Current ecosystem health of lakes in Southland.
- 12 In preparing this evidence, I have read and considered a number of documents, which are referenced throughout my evidence, and a complete list of references is set out in **Appendix A**.

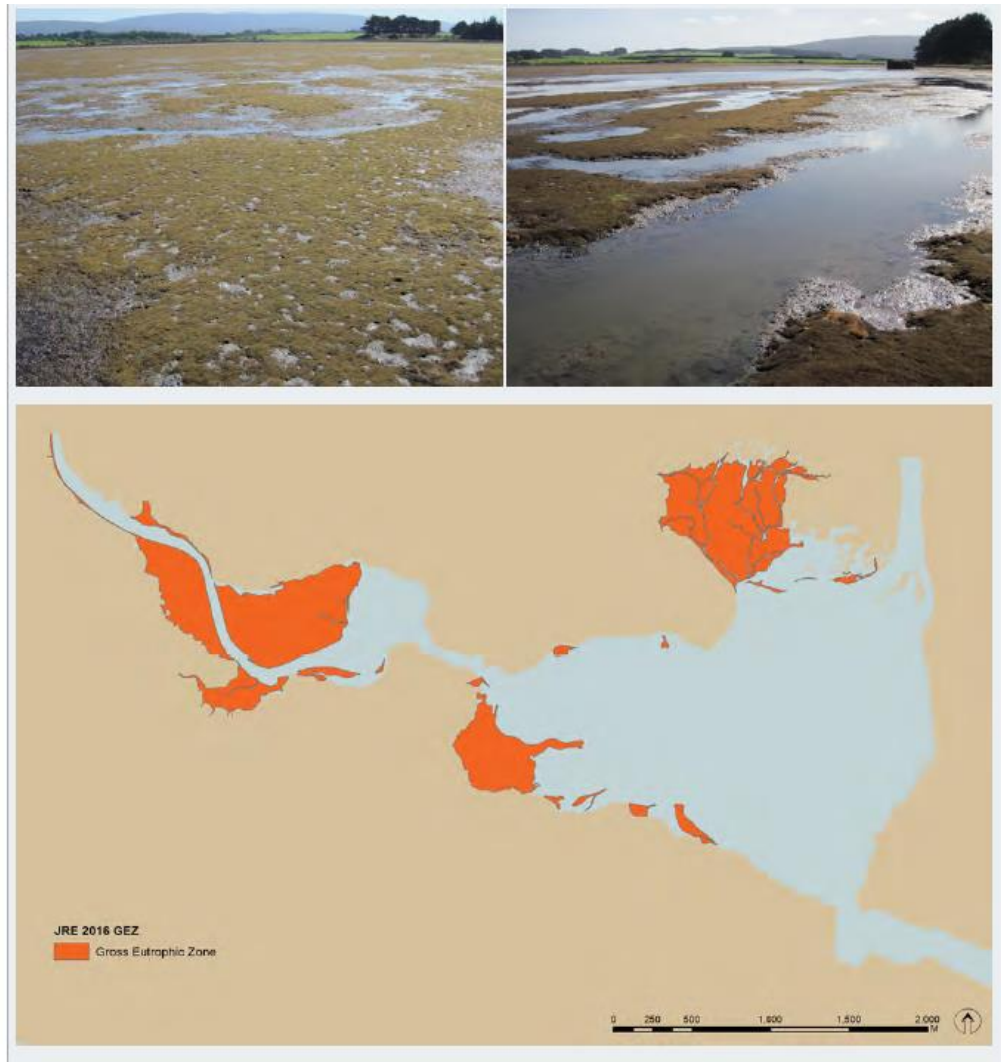
Figure 7. Location and extent of gross eutrophic zones in Jacobs River Estuary 2016. From Robertson et al. 2017

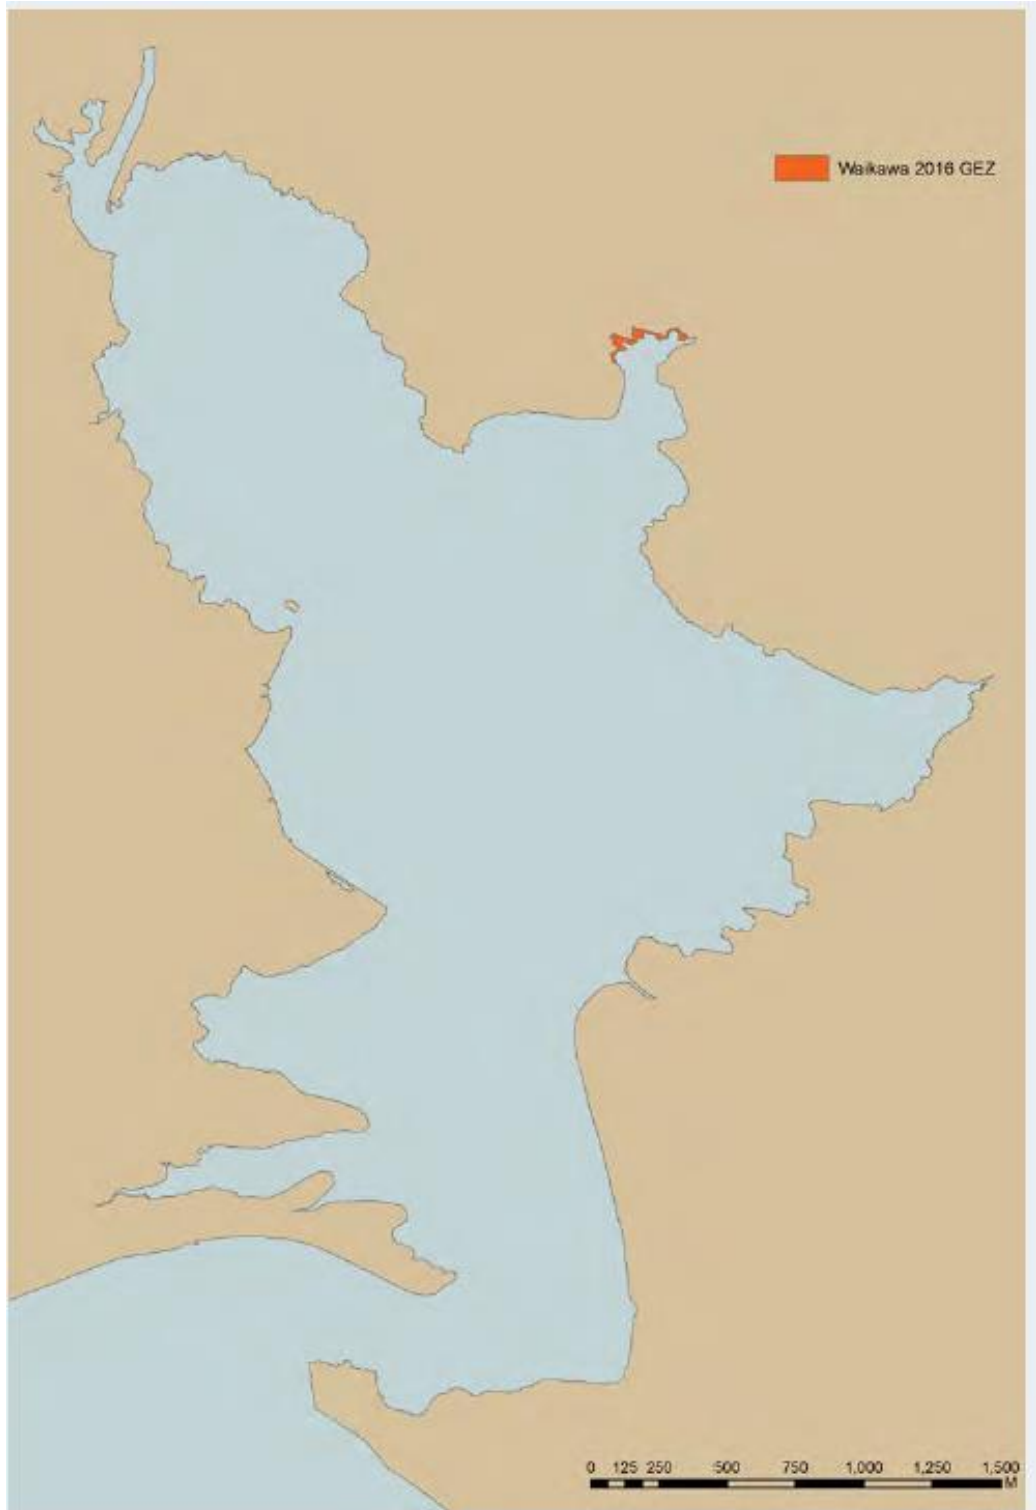
Figure 8. Location and extent of gross eutrophic zones in Waikawa estuary 2016. From Robertson et al. 2017

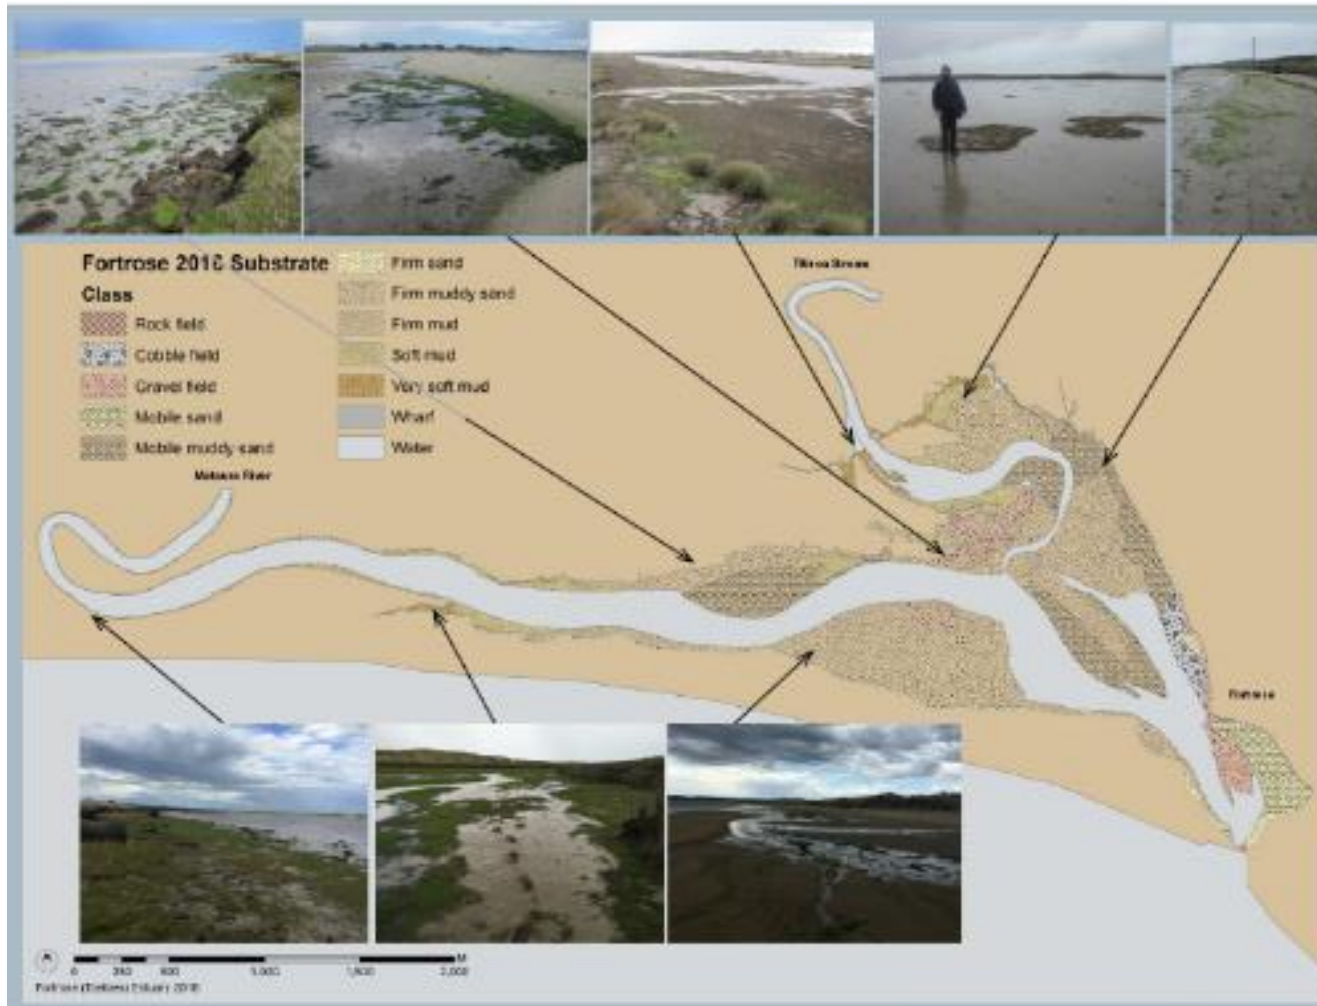
Figure 9. Substrate map for Toetoes (Fortrose) Estuary 2016. From Stevens and Robertson 2017.
