Memo

From	Richard Measures and Jochen Bind
To	Karen Wilson, Environment Southland
CC	Hugh Robertson and Nicki Atkinson, Department of Conservation
Date	20 November 2024
Subject	Validation of Waituna Lagoon inundation and land drainage modelling

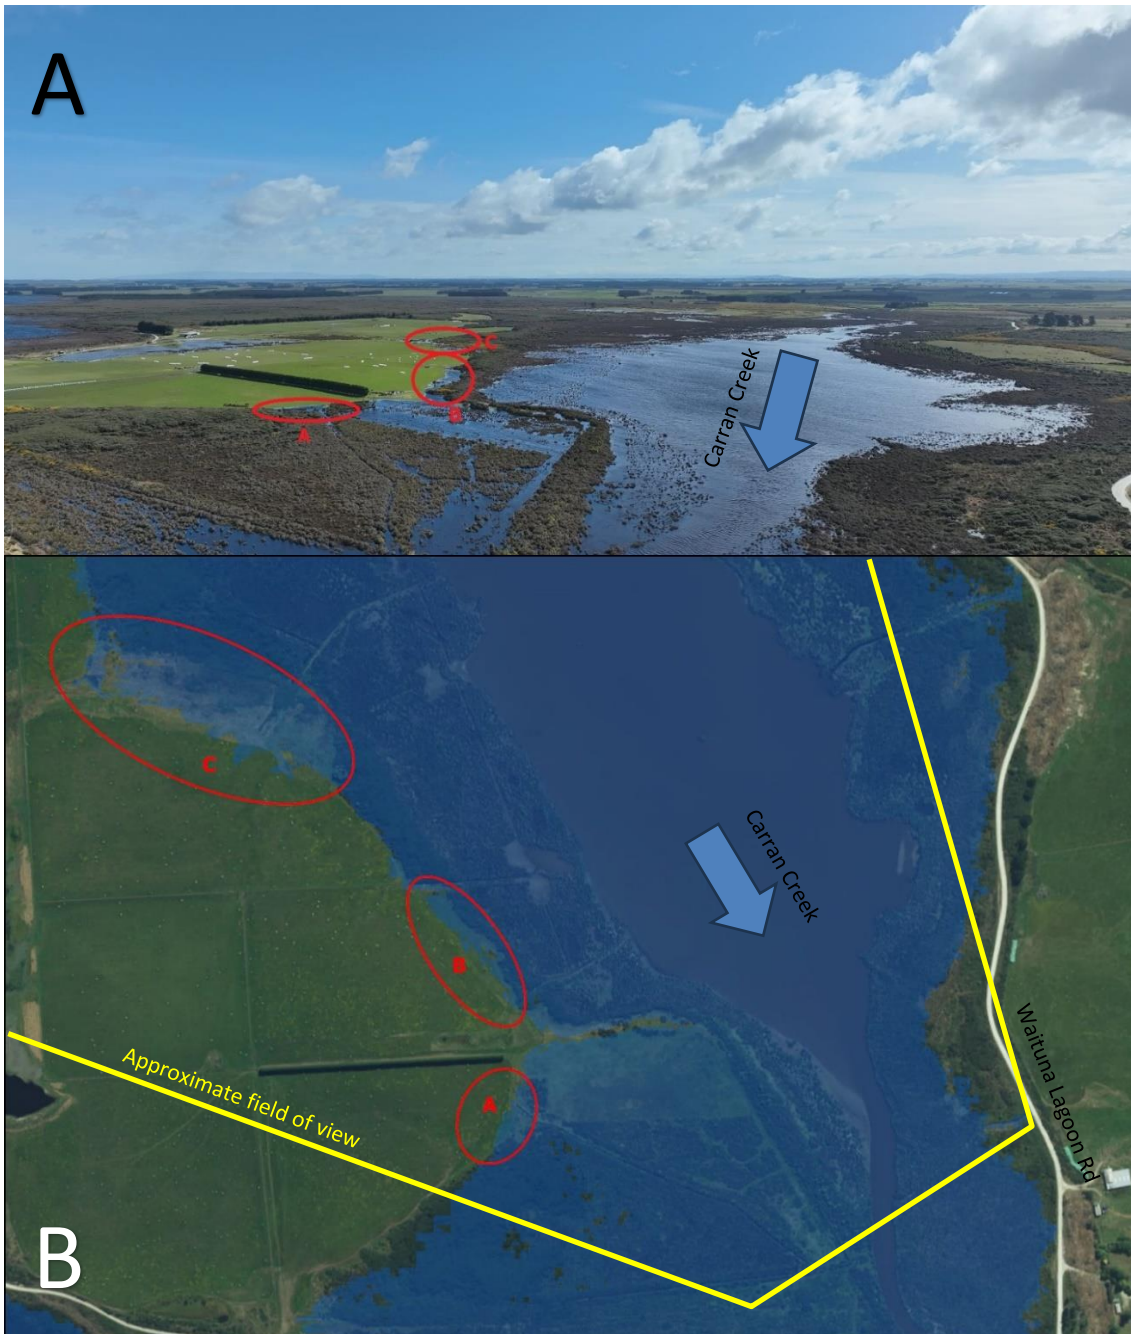
Figure 2A shows the right bank upstream of Waghorn Road bridge on 23 September 2024. The corresponding model result for a lagoon level of 2.5 m is shown in Figure 2B. Within wetland areas emergent vegetation obscures the inundation extent, but three distinct areas of inundation along the farmed edges of the wetland (A–C) can be identified in both aerial image and modelled inundation. There is good agreement between the modelled and observed inundation extent.

Figure 2: Panel A: Carran Creek right bank above Waghorn Road bridge on 23 September 2024 when lagoon level was 2.59 m; Panel B: model results for lagoon level at 2.5 m (modelled inundation extent is the same for all simulated river flows and channel vegetation conditions at this location when lagoon levels are 2.5 m).

- A georeferenced orthophoto created from vertical aerial photos taken of the area around the Waghorn Road bridge and water level recorder on 23 September 2024 (Figure 1).
- An oblique aerial image extracted from video looking upstream from above the Waghorn Road area showing Carran Creek and its true right bank on 23 September 2024 (Figure 2A).

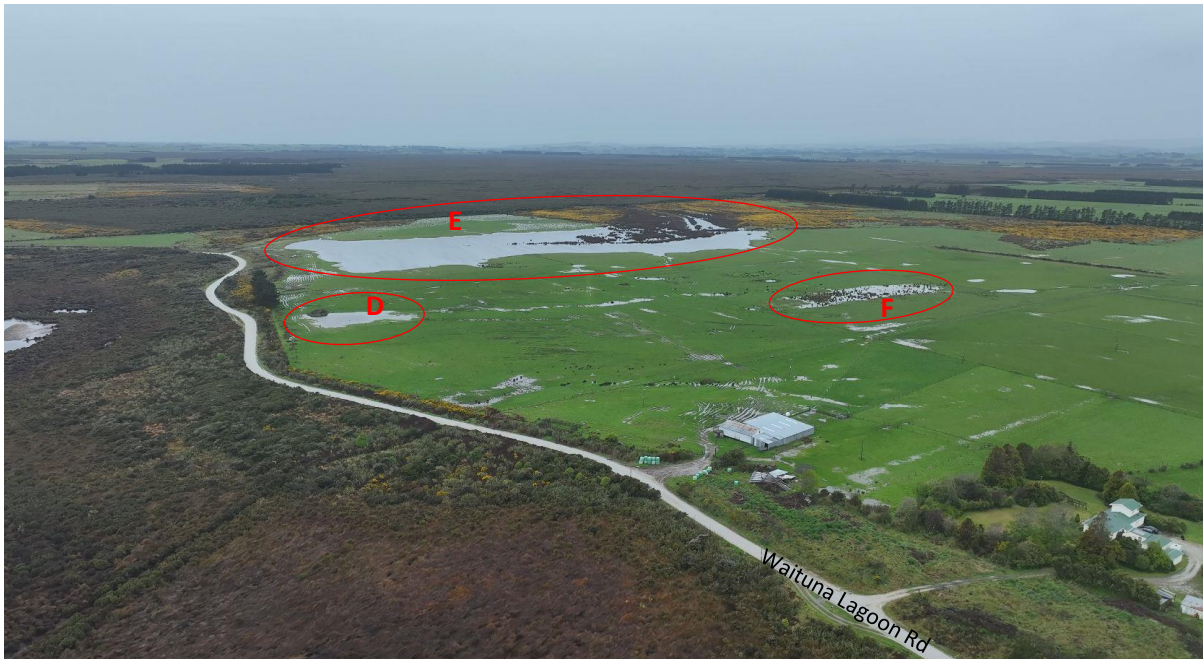
The aerial footage in Figure 4 shows more extensive submerged areas on the left bank of the creek despite the lagoon levels being (much) lower on 24 October 2024 (approximately 0.725 m, almost 2 m lower than in Figure 3A). It is likely that the extensive patches of surface flooding shown in this image (patches D, F, and other additional areas of surface flooding not visible on 23 September 2024, Figure 3) are the result of recent heavy rainfall. Data from the closest ES rain gauge (Waituna at Lawson Road) record 15.5 mm of rain on 23 October and a further 24.0 mm of rain prior to the image shown in Figure 4 being taken at 10:30 NZST. Discharge of Carran Creek at Waituna Lagoon Road was gauged at 11:30 NZST on 24 October 2024 as 3.21 m³/s.

Figure 4: Carran Creek left bank looking upstream from above Waghorn Road bridge on 24 October 2024 when the lagoon was open and lagoon levels were approximately 0.7 m (Creek just outside left side of image).

- An oblique image extracted from video looking upstream over the true left bank of Carran Creek on 23 September 2024 (Figure 3A).
- An oblique image extracted from video looking upstream over the true left (eastern) bank of Carran Creek on 24 October 2024 (Figure 4).

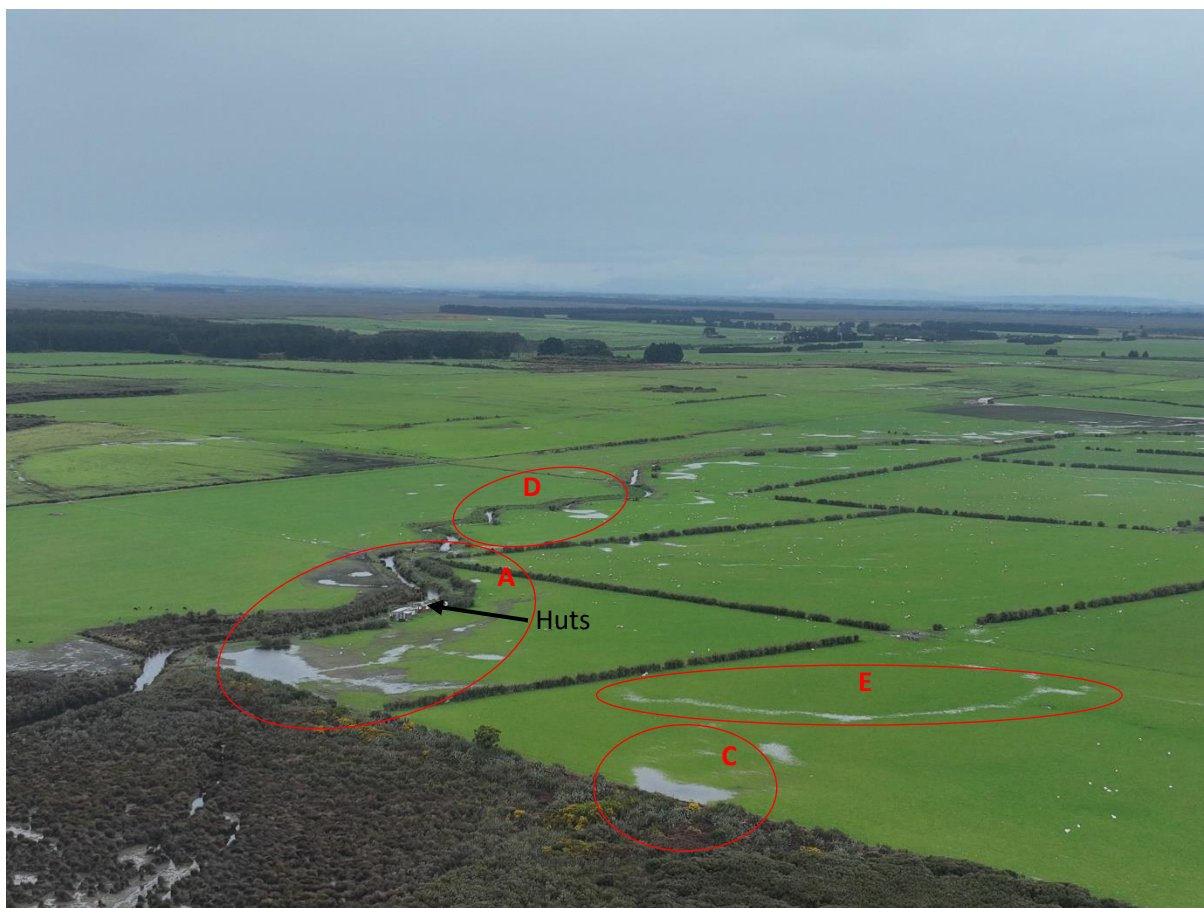
Figure 6 shows the area around the Moffat Creek mouth on 24 October 2024, when lagoon levels were much lower (approximately 0.7 m) and much of the previously inundated land was exposed. However, muddy areas that had been submerged can be seen behind the fishing huts and there is a shallow, water-filled channel visible in the paddock (patch E) that was not inundated in the imagery from 11 September 2024. The water in this depression/channel is likely rain-runoff from the heavy rain which preceded the survey on 11 September. Patch C is also clearly still inundated, which supports the theory of a local depression, filled with run-off water.

Figure 6: Moffat Creek on 24 October 2024. Lagoon open, lagoon water level approximately 0.7 m, creek flow very high (greater than 90th percentile).

- A wide-angle view of Moffat Creek and farmland either side just upstream of its mouth (taken from above the end of Moffat Rd on 11 September 2024 (Figure 5A)).
- A zoomed-in view of farmland on the true left bank of Moffat Creek from above end of Moffat Rd on 11 September 2024 (Figure 5B). This image was selected to provide more detail of inundated areas.
- A wide-angle view of Moffat Creek and farmland either side just upstream of its mouth on 24 October 2024 (Figure 6)

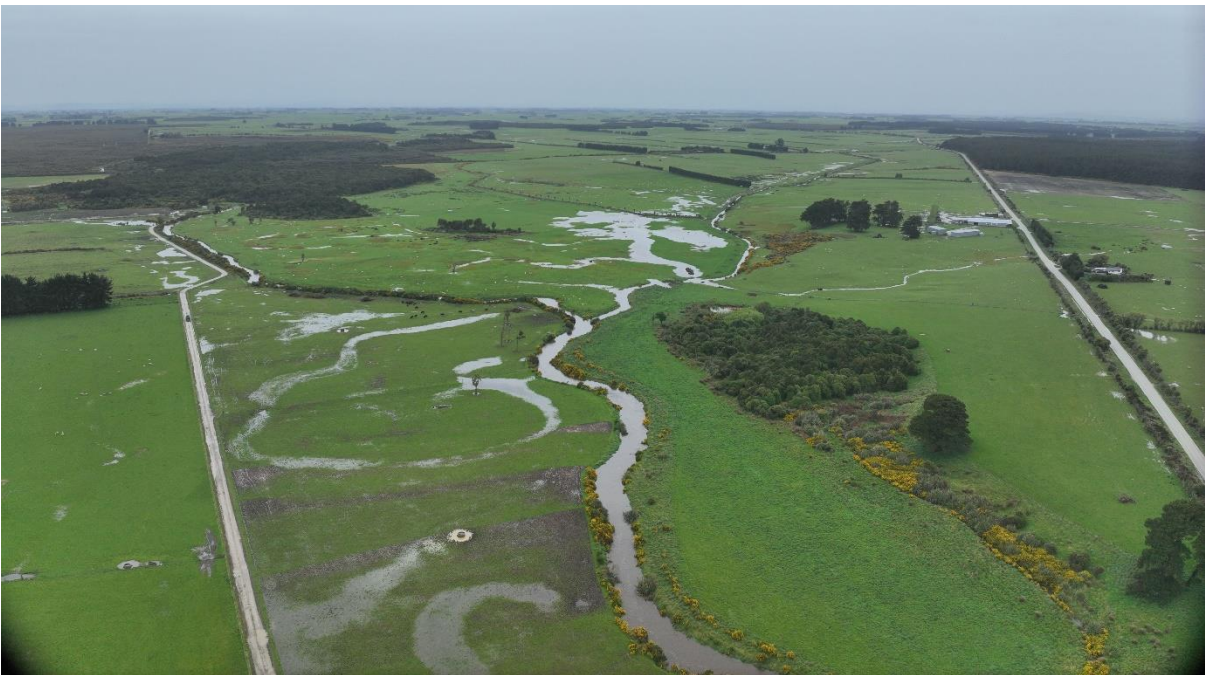
Figure 7: Waituna Creek on 24 October 2024, looking upstream along Marshall Road (right in image). Lagoon open, lagoon water level approximately 0.7 m, creek flow very high (greater than 90th percentile). The upstream end of the Waituna Creek Model is below the UAV, just outside the frame at the lower margin of the image.

Images and videos were collected from UAV from above the bend in Marshall Road north of Hanson Road on 25 October 2024 around 11:00 NZST. Two images were selected, Figures 7 and 8 show the view upstream and downstream, respectively. Many low-lying areas (particularly the depressions of old meander channels) are filled with water.

Unfortunately, the area captured in the images and video is mostly beyond the reach covered by 2016 modelling study and there are no images which can be used to validate the area around the mouth of Waituna Creek. Figure 7 shows the area immediately upstream of the model inflow boundary while Figure 8 shows the area around the inflow boundary for the model. However, they are still relevant to discuss as they show inundation, but the modelling study showed that the backwater effect of lagoon levels does not extend this far up stream (Figure 9). Land elevations in the inundated areas shown in the imagery (all

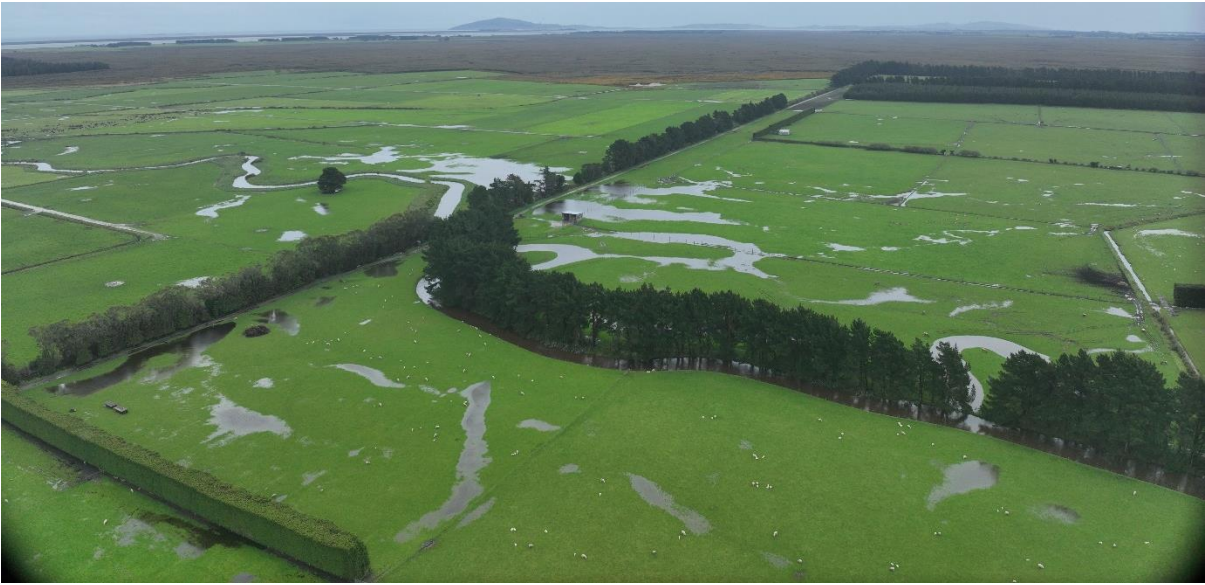
Figure 8: Waituna Creek on 24 October 2024, looking downstream from Marshall Road, North of intersection with Hanson Road. Lagoon open, lagoon water level approximately 0.7 m, creek flow very high (greater than 90th percentile). The upstream end of the Waituna Creek Model coincides with the right margin of the aerial photo. The model shows no inundation in this reach.

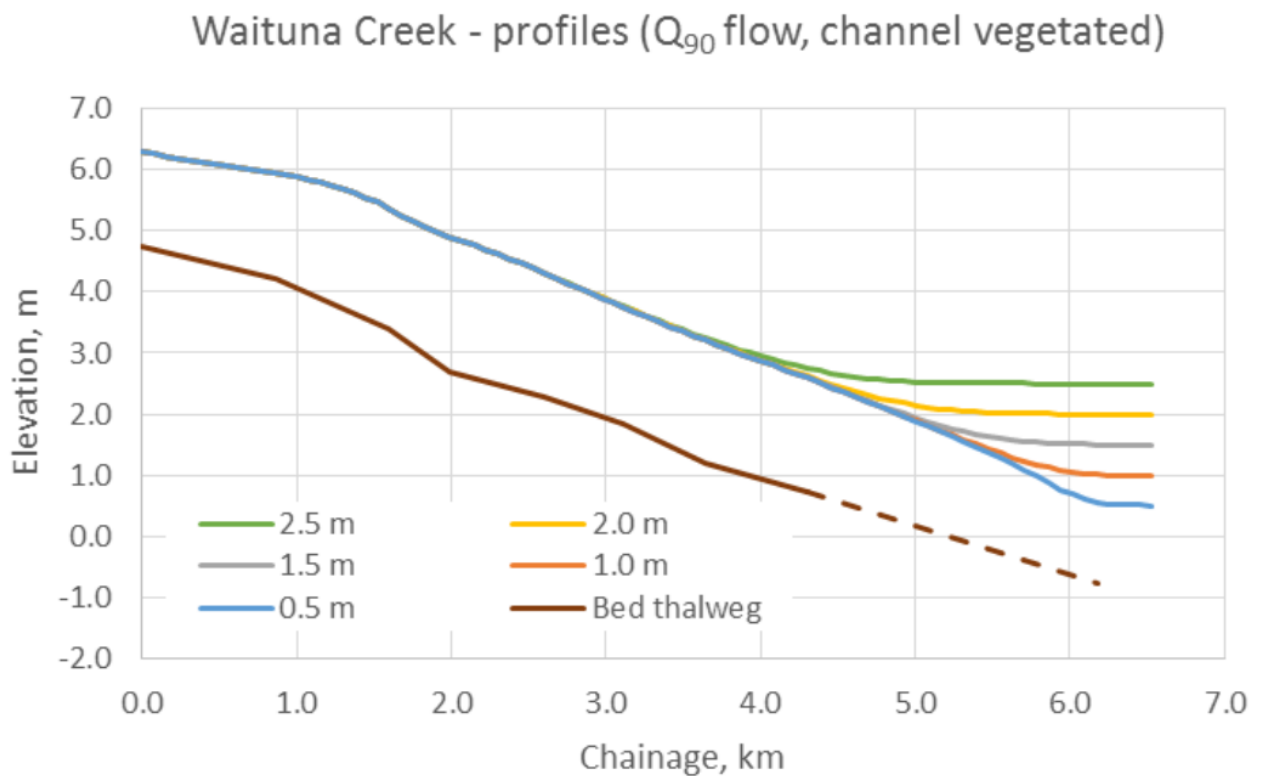
Figure 9: Modelled Waituna Creek backwater profiles (reproduced from Figure 4-8 of Walsh et al. 2016). Figures 7 and 8 show the area around chainage 0.0 km in the plot above.
