RE: Request for Further Information under Section 92(1) of the Resource Management Act 1991 - Application for a discharge permit and a water permit

Application to abstract groundwater

Application to discharge dairy shed and feed pad effluent to land

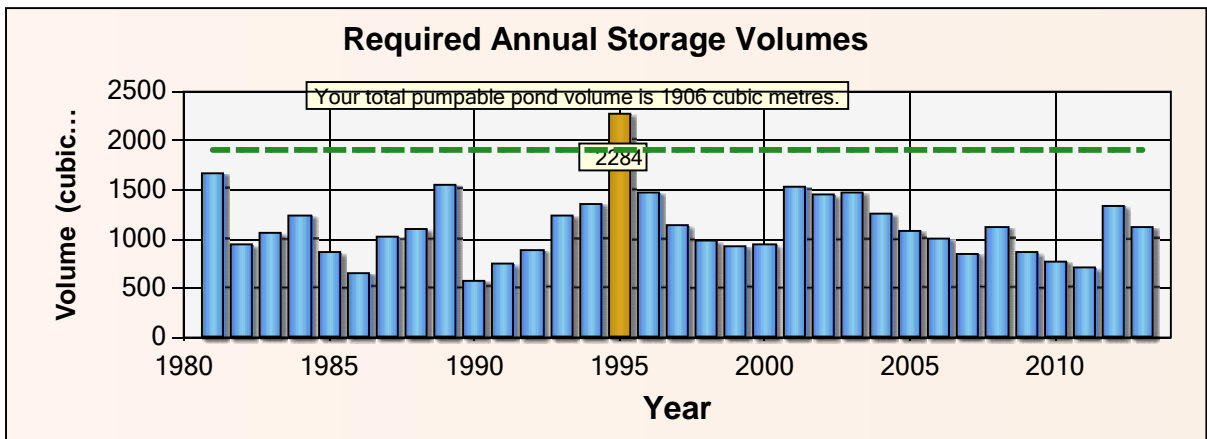
Maximum required storage pond volume: 2284 cubic metres
 90 % probability storage pond volume: 1581 cubic metres
 During the period from: 01 July 1980
 To: 30 June 2013

Please see Attachment A for the revised DESC using 32.69 L/cow/day. Using this value for yard wash down, the pond volume requirement is now 1581 cubic metres. The pond's current storage capacity of 1906 cubic metres is still adequate.

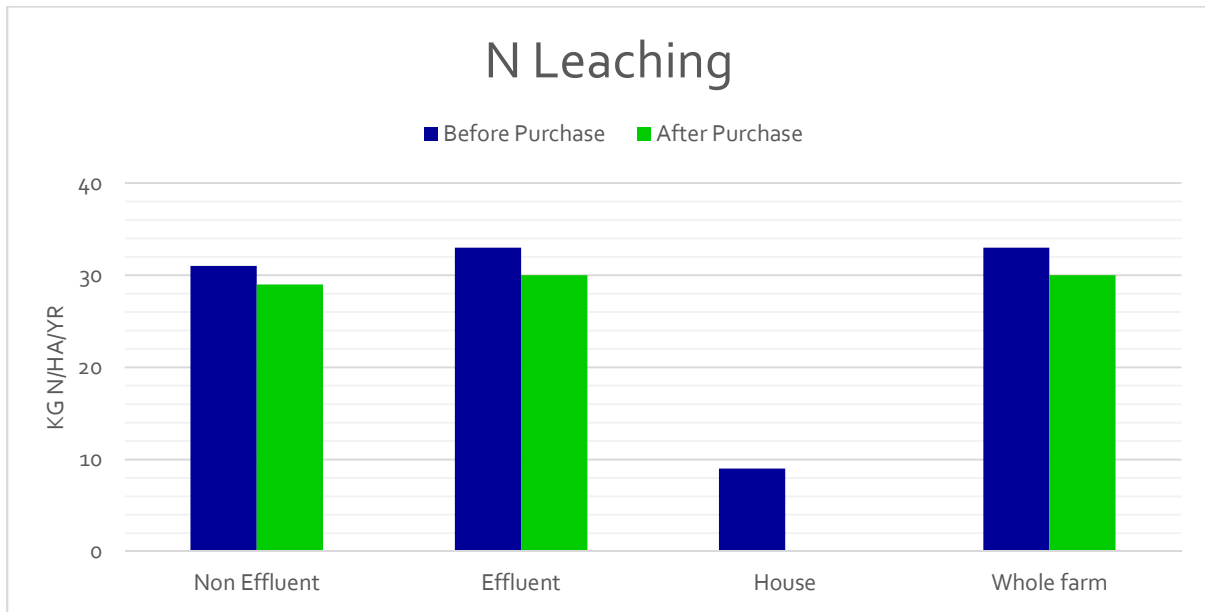
The N leaching on the proposed dairy farm is 3 kg N/ha/yr less than the previous year over the whole farm.

Of note the total N loss from the whole farm in the 2016 – 2017 year is 7,235 kg N/yr. In the 2015 – 2016 year the N loss from the whole farm and House block is 7,684 kg N/yr. This has decreased with new area incorporated into the dairy farm.

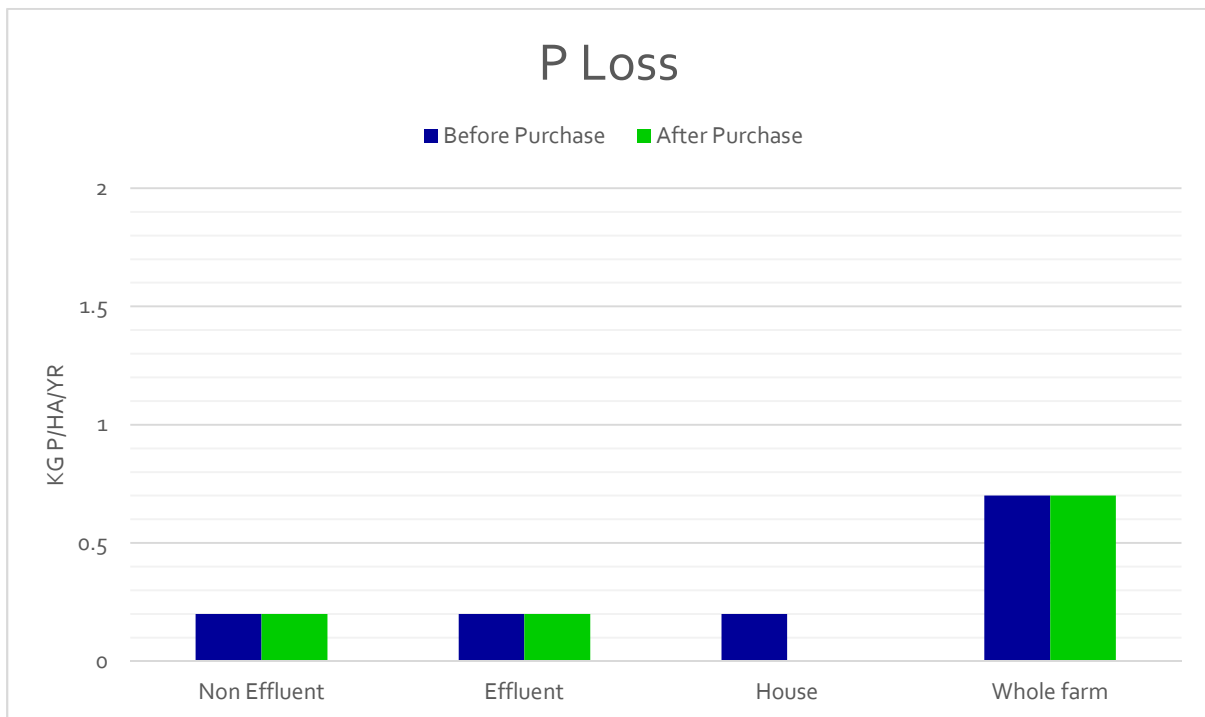
There is no difference in P loss from any of the nutrient budgets.

Phosphate losses for the whole farm are low at 0.7 kg P/ha/yr. All blocks have very low P losses of 0.2 kg P/ha/yr. The increase over the whole farm is due to losses from the wintering barns and lanes etc.

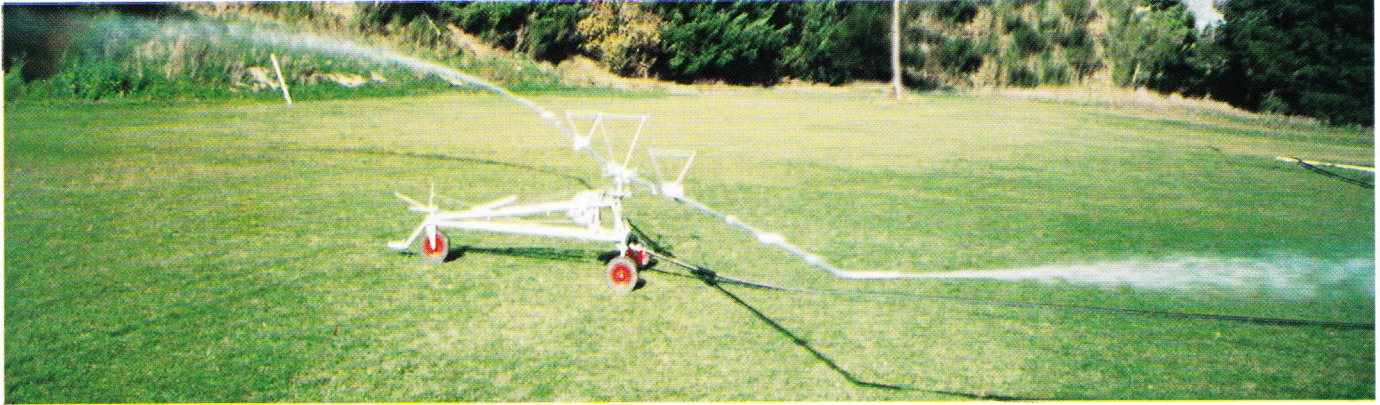
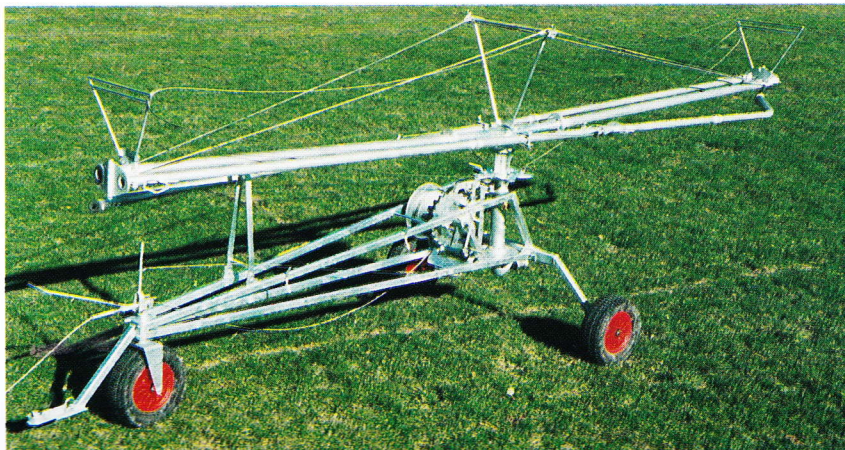
BRIGGS MODEL 15 **Effluent Applicator**

The Briggs Effluent Applicator performs a complex task by means of a few simple mechanisms. The retro-action of the effluent causes the boom to rotate for an even spread of effluent. The rotation of the boom provides the motive force that propels the machine using a drive roller rotating around a series of cams which operates a simple lever mechanism to the wire rope winch drum.

The Briggs Model 15 Effluent Applicator dragging a 150 metre length of 63mm medium density polyethylene hose operating at a flow rate of 20m³/hr (75 gpm) with a wetted width of 35 metres, will on its fastest travel speed of 85m/hour apply effluent onto the ground at a rate of 6.7mm per pass. On the slowest travel speed of 17m/hour this applicator will apply 34mm of effluent per pass.

Boom Length	15 metres
Wetted Width	35 metres
Lane Spacings	35 metres
Hose Length	up to 150 metres
Run Length	up to 300 metres
Hose Diameter	up to 63mm
Flow Range	2 to 6 L/s
Operating Pressure	150 to 250 k.p.a. (20 to 30 psi)
Travel Speeds	17 to 85 metres per hour
Area Covered	1.05 hectares (300m Run)

The model of the travelling irrigator is Briggs Model 15. The maximum depth of application is 25 mm for each individual application. The manufacturer’s specification is attached (Attachment C).

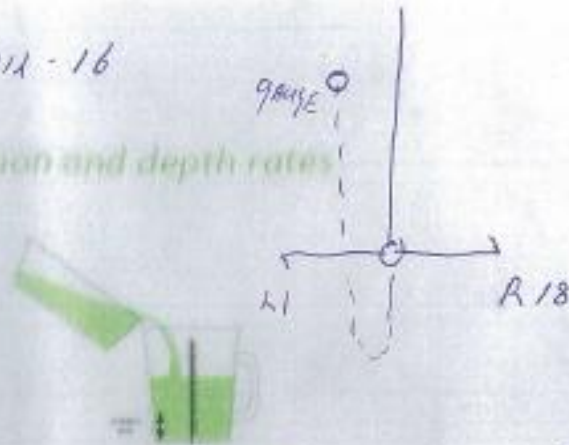
Paddock 47
 BRISSES 15
 picking up 5 cans

L1	10	630	1425	1070	880	730	745	670	715	710
----	----	-----	------	------	-----	-----	-----	-----	-----	-----

680	710	750	880	1175	1675	1150	R18	20	TOTAL (ml)	14625
-----	-----	-----	-----	------	------	------	-----	----	------------	-------

TOTAL (ml)	NUMBER OF CONTAINERS	AVERAGE VOLUME (ml)
14625	18	= 812.5

CONTAINER WIDTH (mm)	CONTAINER LENGTH (mm)	CONTAINER AREA (mm ²)
242mm	X 366mm	= 88572 mm

1000	X	AVERAGE VOLUME (ml)	CONTAINER AREA (mm ²)	AVERAGE APPLICATION DEPTH (mm)
		812.5	88572 mm	= 9.17

AVERAGE APPLICATION DEPTH (mm)	TIME (hrs)	AVERAGE APPLICATION RATE (mm/hr)
9.17	= min/60 0.51	= 17.9

- Operating pressure = **39 PSI (spec give 30)**
- Flow rate = **6.8 l/sec on average**
- Effluent volume = **12.8 cubic meters total for a 31 min run(25 cubes/hour)**
- Average application depth = **9.17 mm**
- Maximum application depth from tray 6 = **18.9 mm**

Your discharge consent will require a maximum depth of application of 10mm for a high rate travelling irrigator; you meet this requirement with your average depth of 9.17 mm.
