IN THE MATTER of an application by Meridian Energy Limited for the resource consents related to the construction of a new channel to enable a permanent diversion of part of the flow of the Waiiau Arm and the associated removal of bed material and gravels, together with any maintenance and ancillary activities.

STATEMENT OF EVIDENCE IN CHIEF OF MARTIN SINGLE

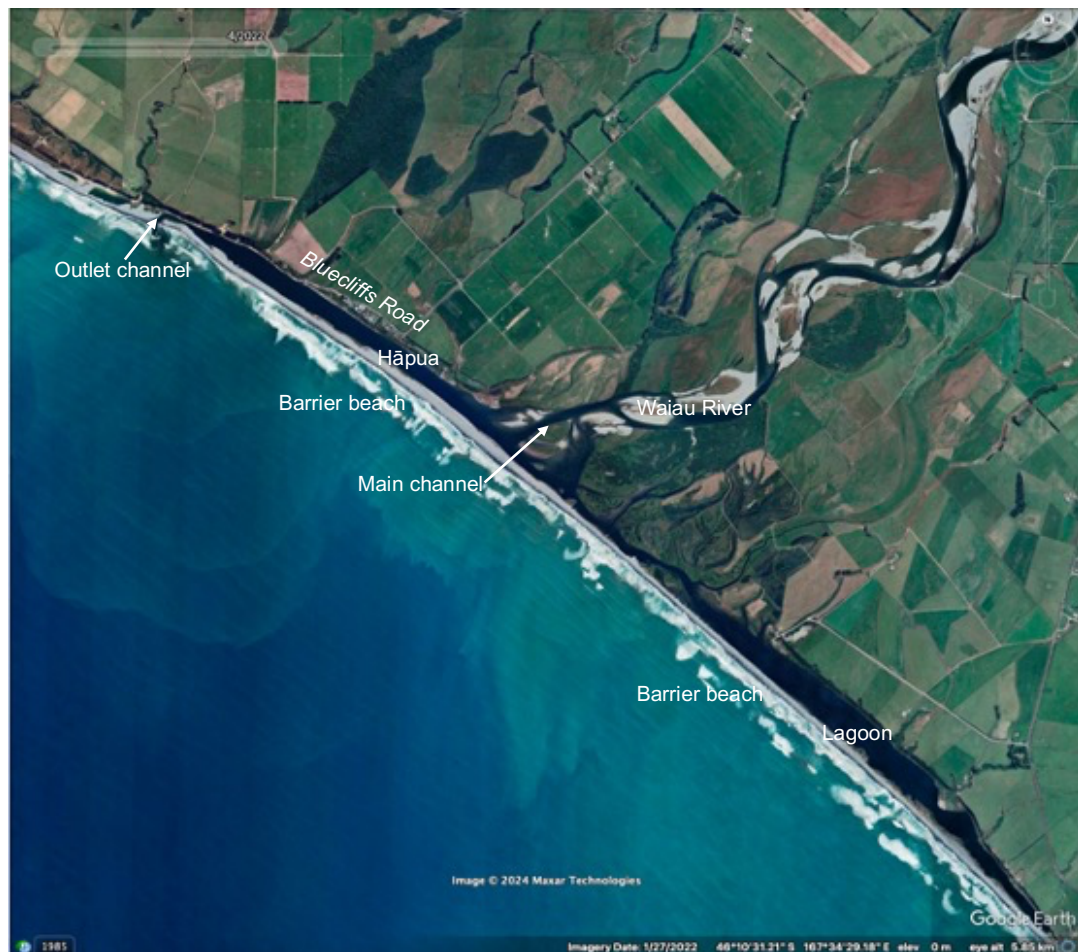
28. Figure 1 shows the Waiau River and associated hāpua and lagoon. The main channel of the river is noted as is the barrier beach impeding the direct flow of the river to the sea and enclosing the hāpua and lagoon water bodies. The outlet to the sea at the time of the photograph (27 January 2022) is at the far western end of the hāpua and is a narrow channel through the barrier beach.

Figure 1 – Waiau River mouth area (Image from GoogleEarth)

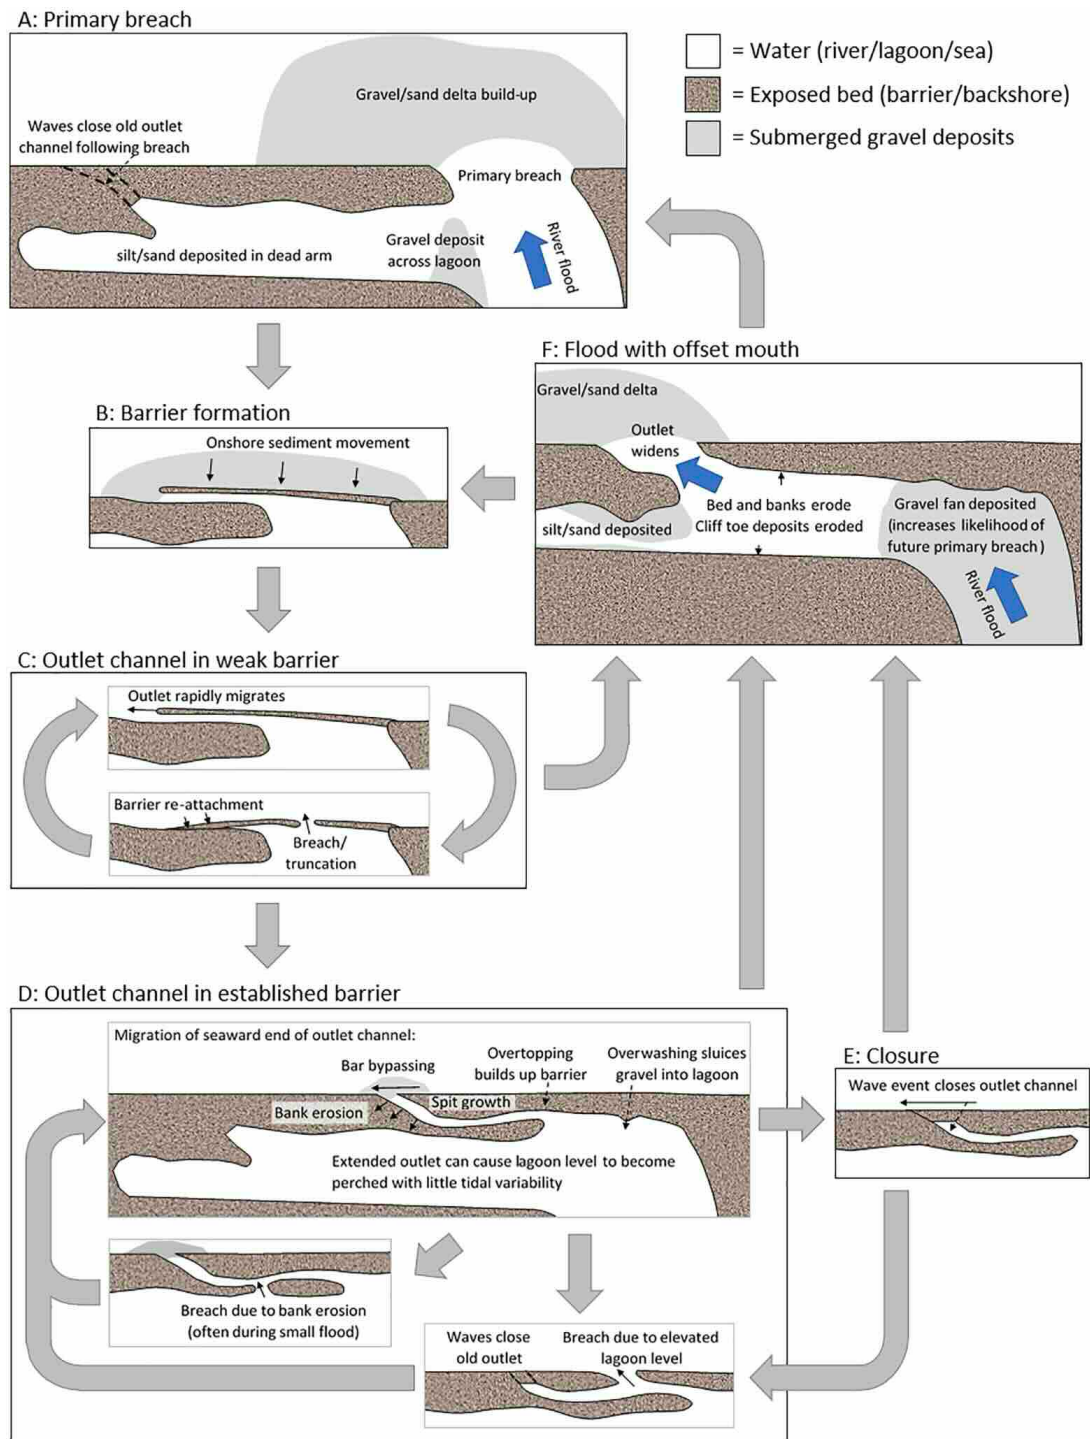
46. Hart (2009) and Measures *et al.* (2020) have described a distinctive sequence of river mouth offsetting and freshwater lagoon development following floods for several South Island hāpua, including the Waiau, Waitaki, Opihi, Rangitata, Ashburton, Rakaia and Hurunui River mouths. In this sequence, during large floods the mouth is open to the sea opposite the main river channel, where a lobate 'delta' of fluvial sediment is deposited into the nearshore. This is shown in "A" in Figure 2.

47. After the floodwaters recede, this sediment is pushed landward by waves and transported along the shore seaward of the river mouth. A spit forms across the river mouth in the direction of longshore transport, offsetting the outlet to the sea. The narrowed outlet migrates along the shore in the direction of longshore drift, transformed from a wide, shore normal channel to one flowing diagonally through the barrier beach ("B" and "C" in Figure 2).

Figure 2 – Hāpua conceptual morphodynamics (Source: Measures, Hart, Cochrane, Hicks 2020, Processes controlling river mouth lagoon dynamics on high-energy mixed sand and gravel beaches Marine Geology, 420).

48. As the river mouth becomes progressively choked, water ponds behind the barrier, increasing the length of the lagoon. The hāpua will remain in a state of fluctuating outlet migration and lagoon growth until another large flood breaches the barrier in front of the main river channel (a 'direct breach'), truncating the lagoon, and the cycle begins anew ("D" and "F" and links in Figure 2).

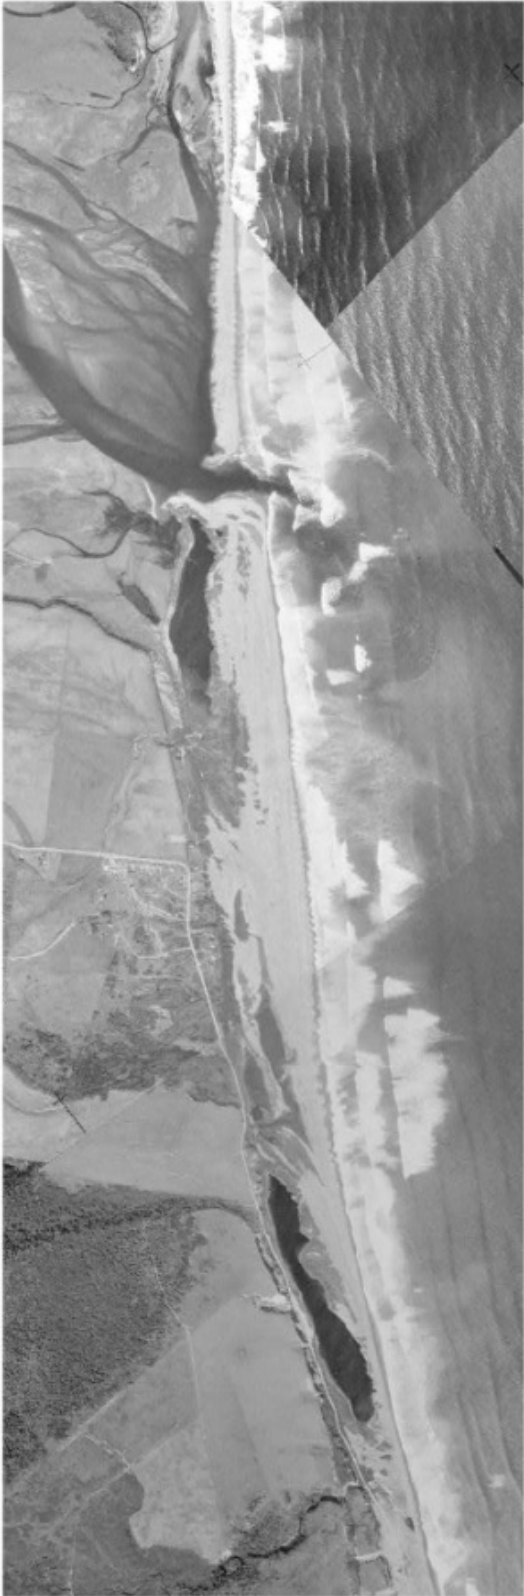
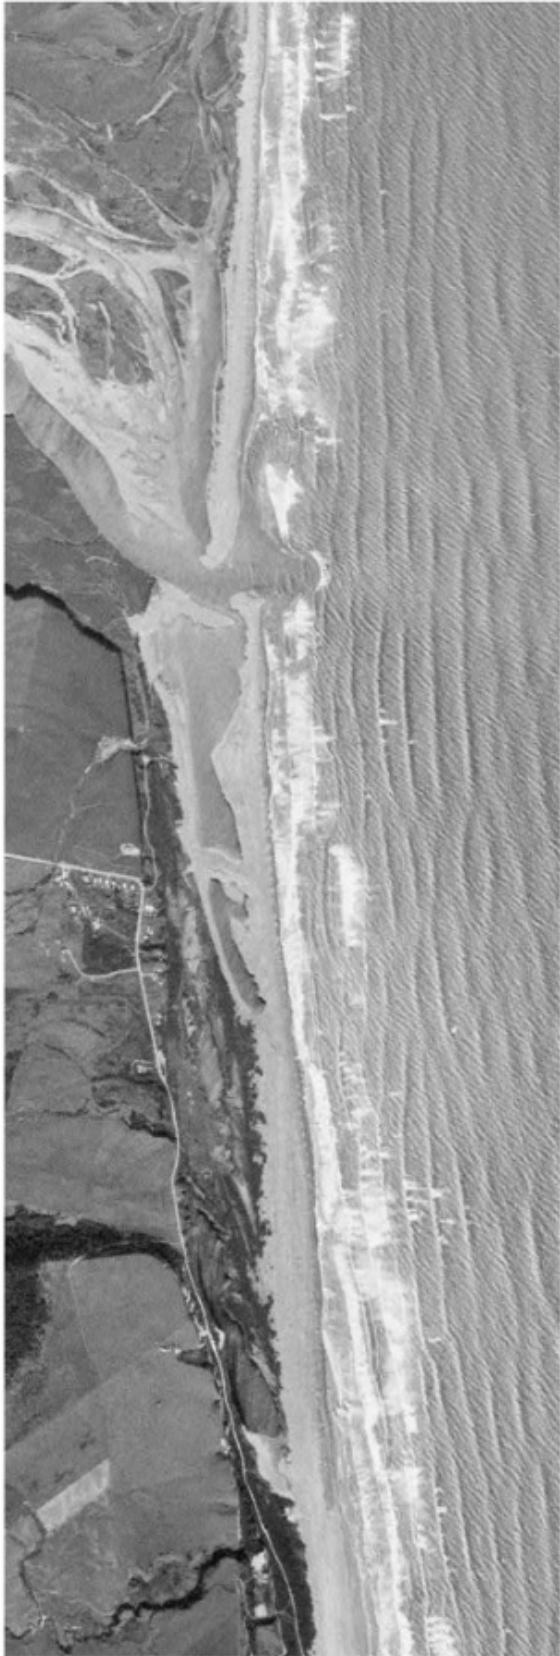
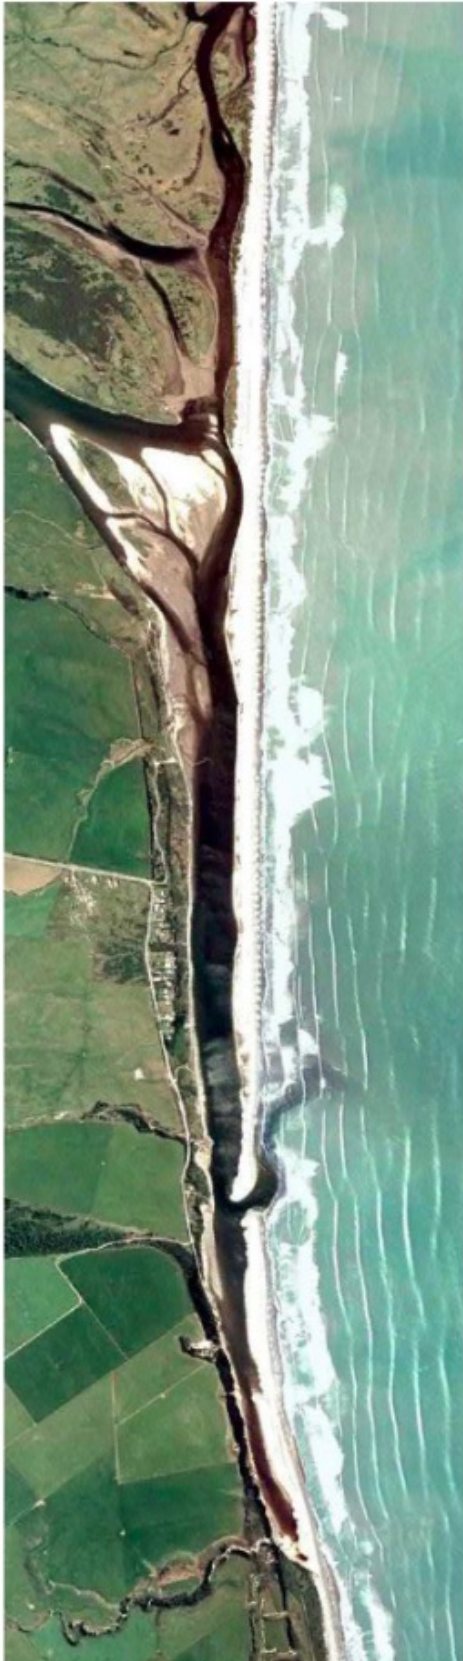
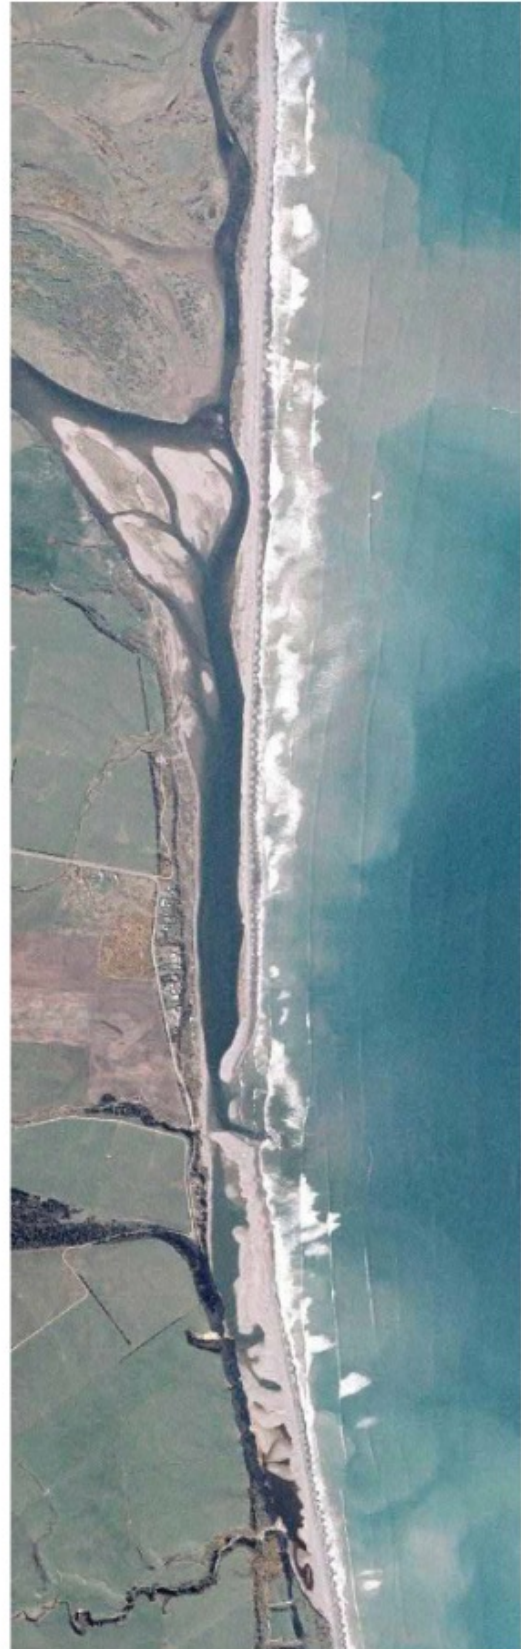
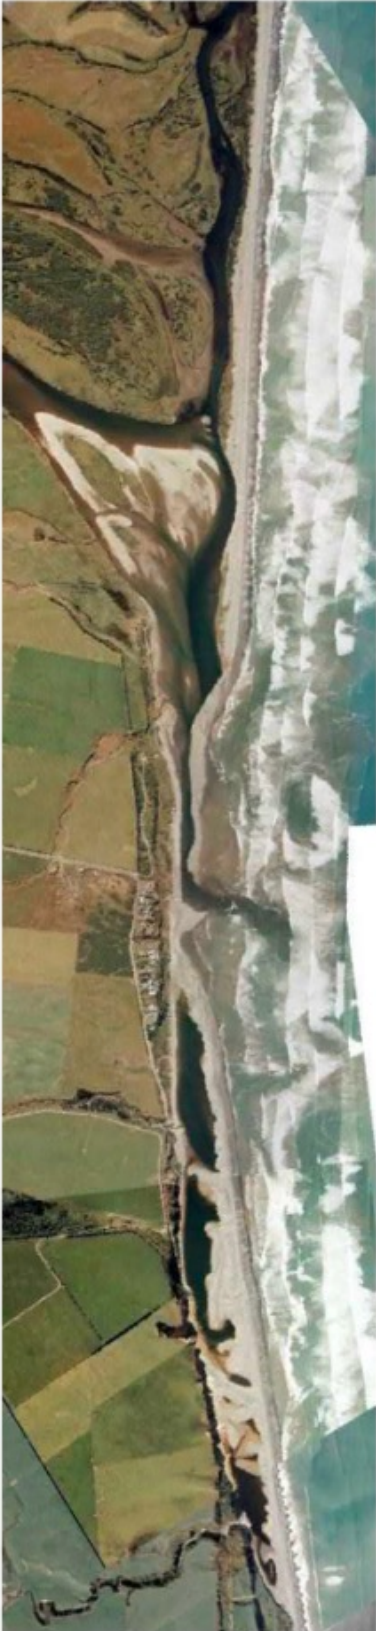
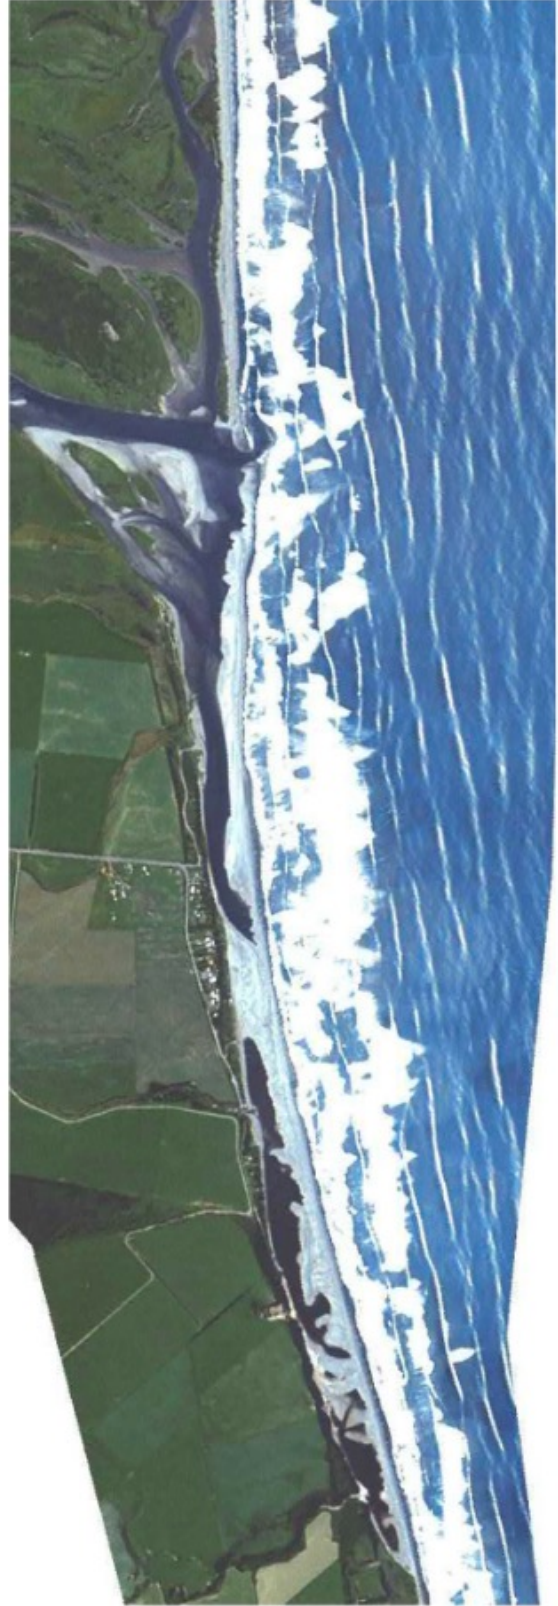
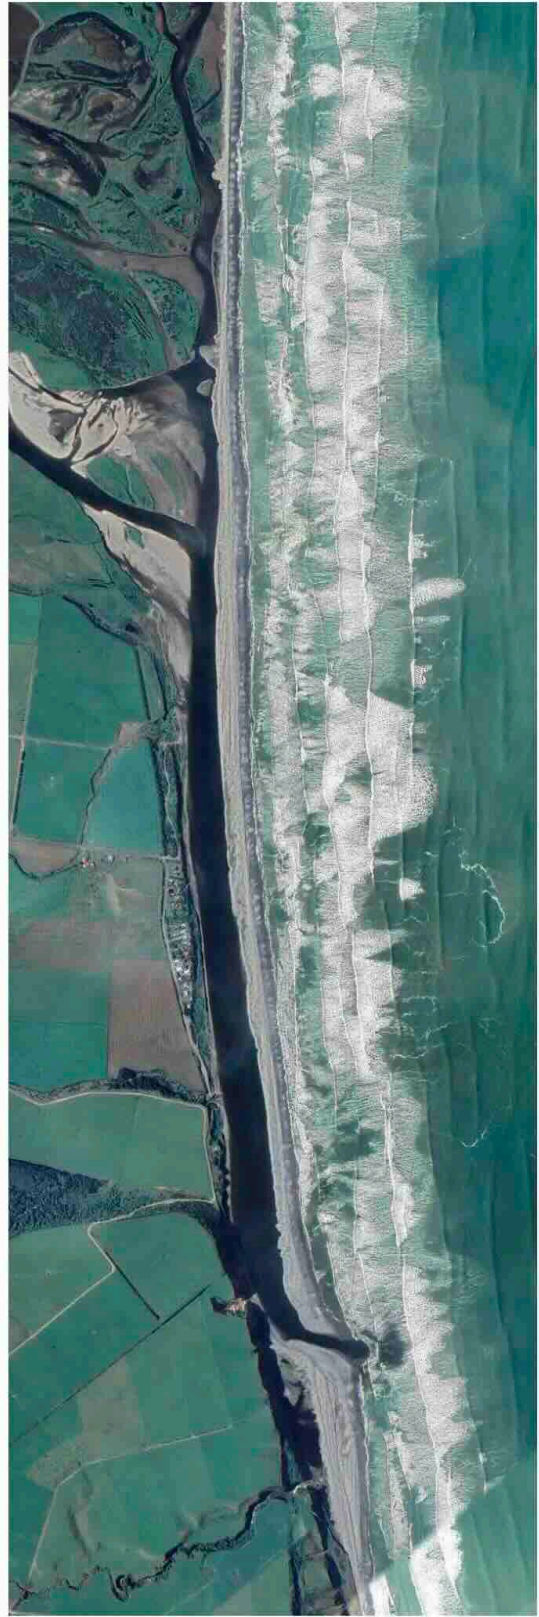
APPENDIX 4 – A SELECTION OF AERIAL PHOTOGRAPHS OF THE WAIU RIVER MOUTH AND HĀPUA

68. A selection of aerial photographs is included in Appendix 4. These show that the dynamic nature of the hāpua processes is a long-term aspect of the Waiau River. These types of changes are consistent with hāpua dynamics observed and measured in Canterbury and with the type of coastal change associated with hāpua as found at the Rangitata, Ashburton and Hurunui River mouths, and with the coastal geomorphology along the Te Waewae coast southeast of the Waiau River valley.
