Subject: Visual Assessment report for assessment of twin weeping wall sludge beds.

- Area 1: twin weeping wall sludge beds located at the dairy shed – **PASS**

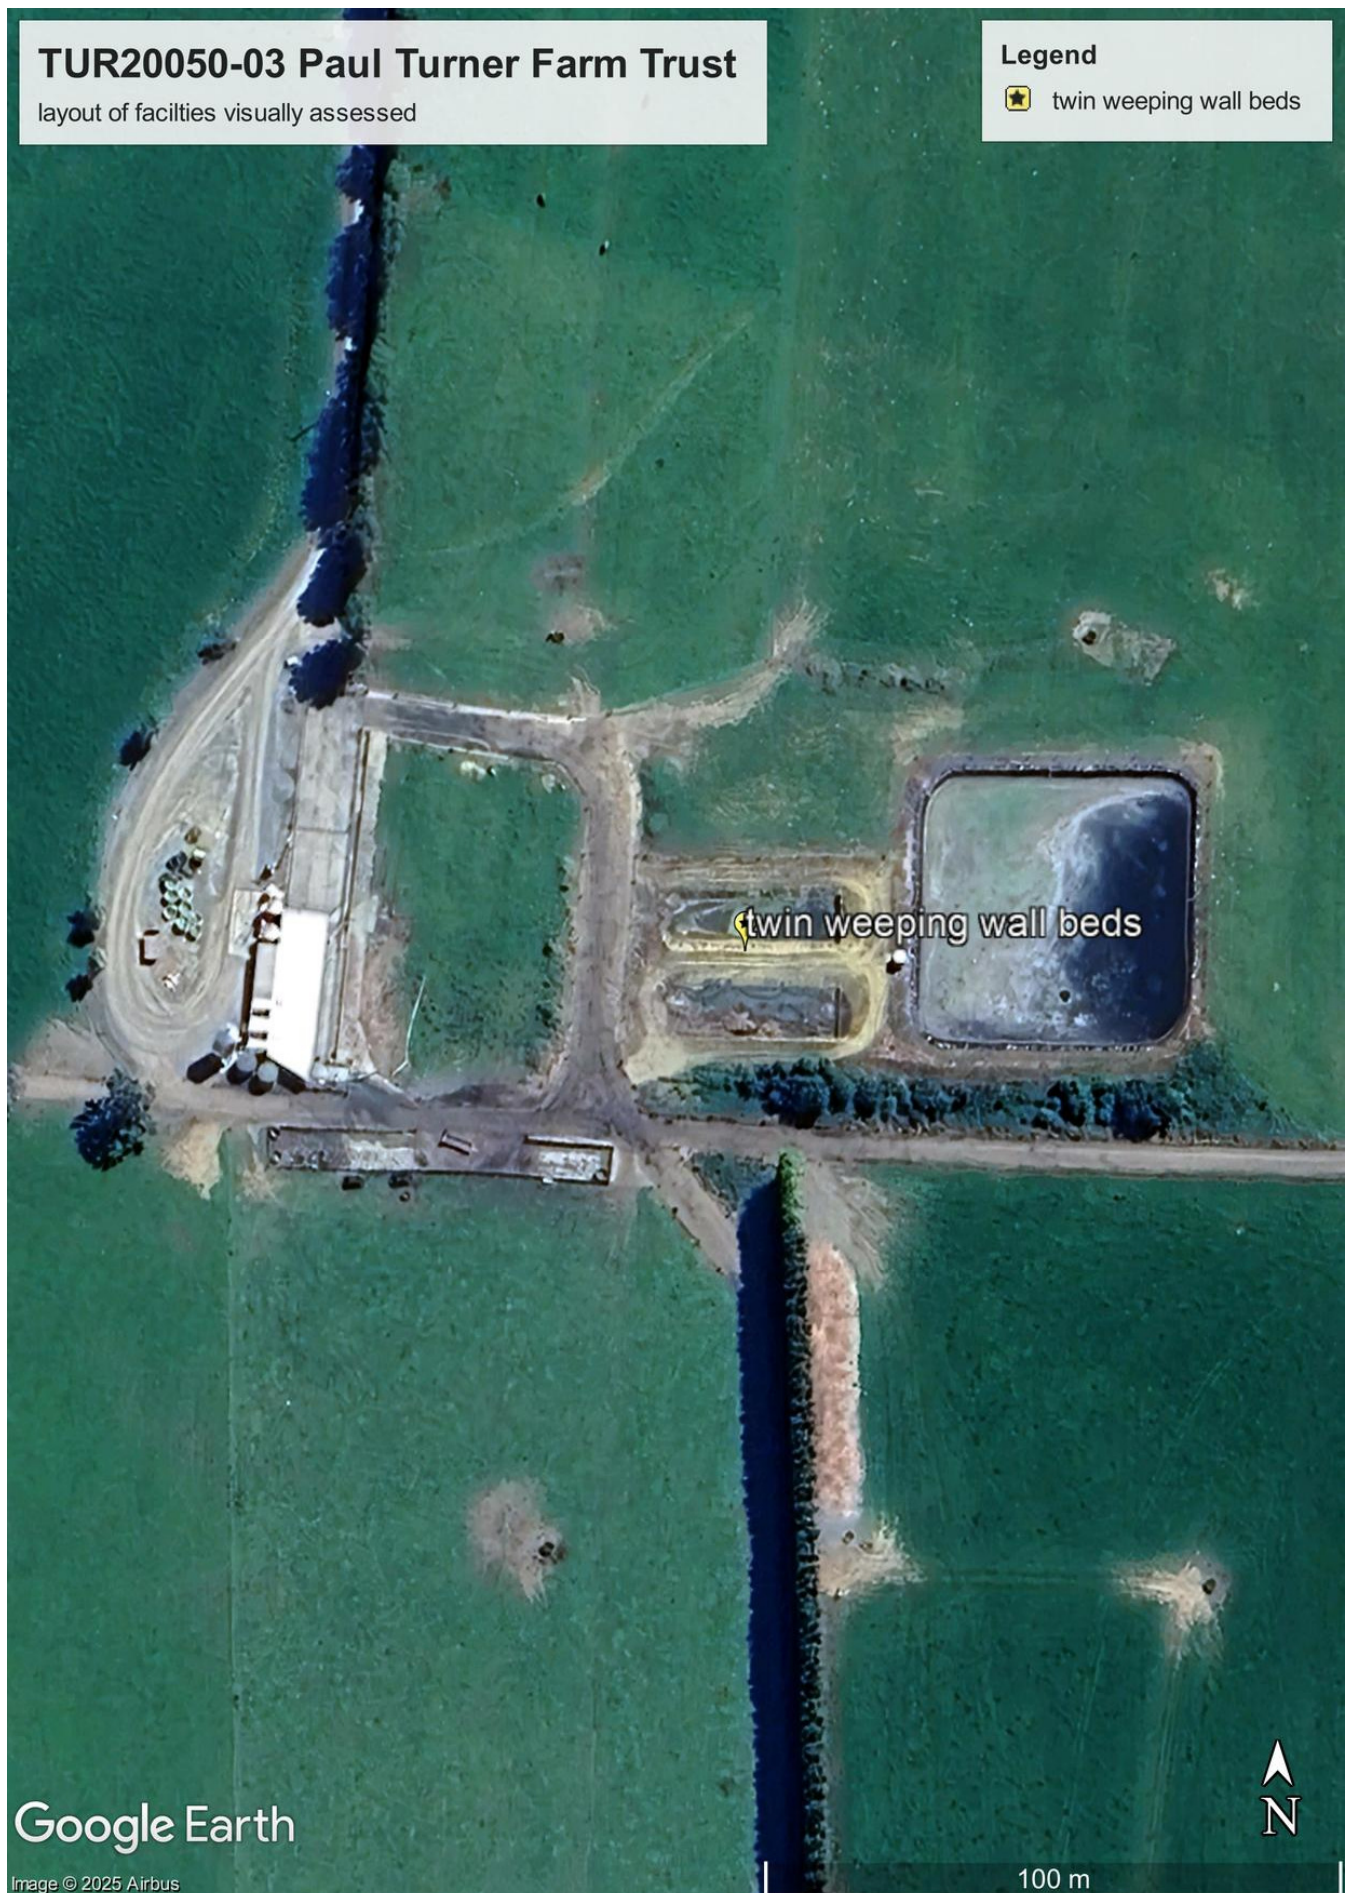
Figure 1 Layout of the facilities visually assessed.

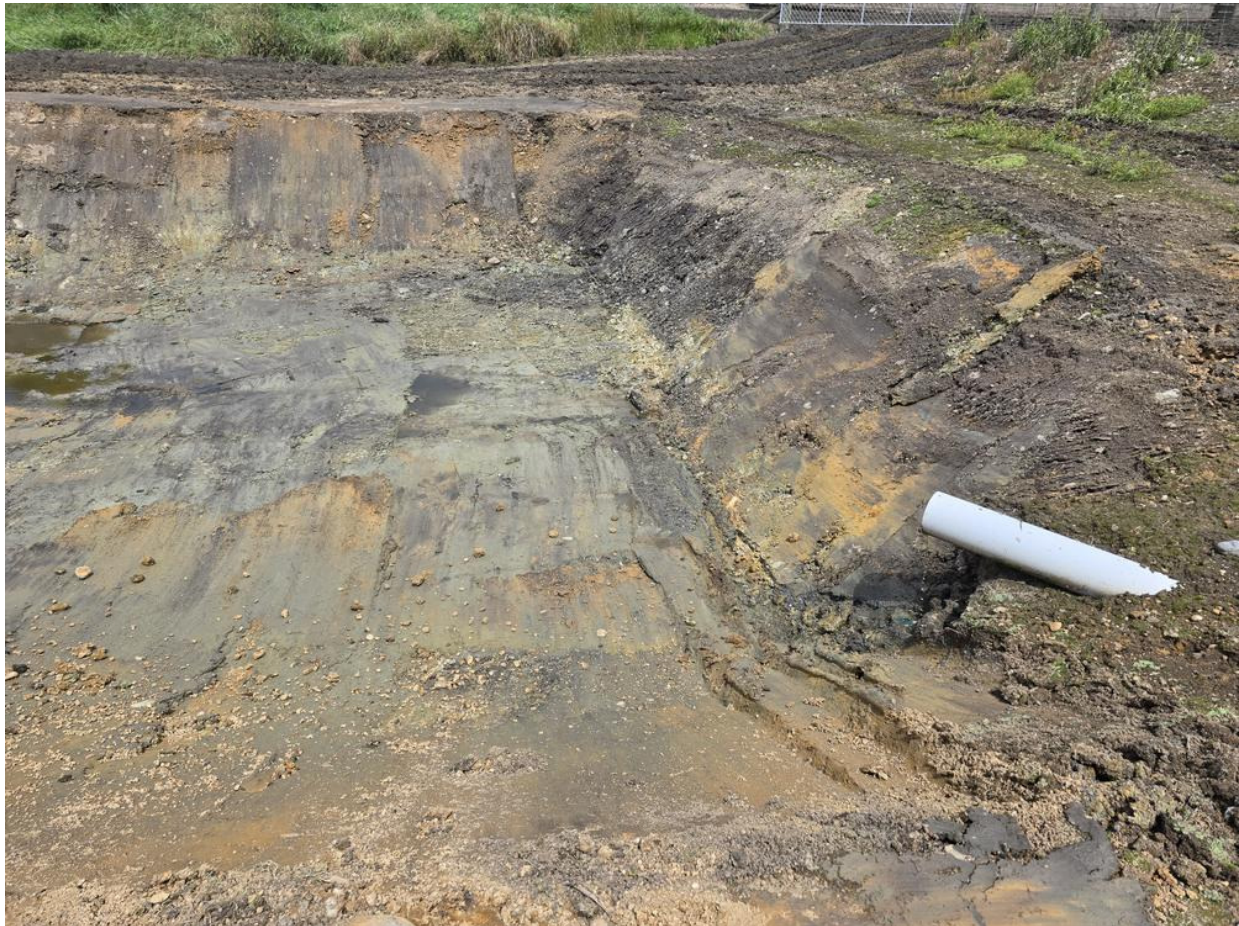
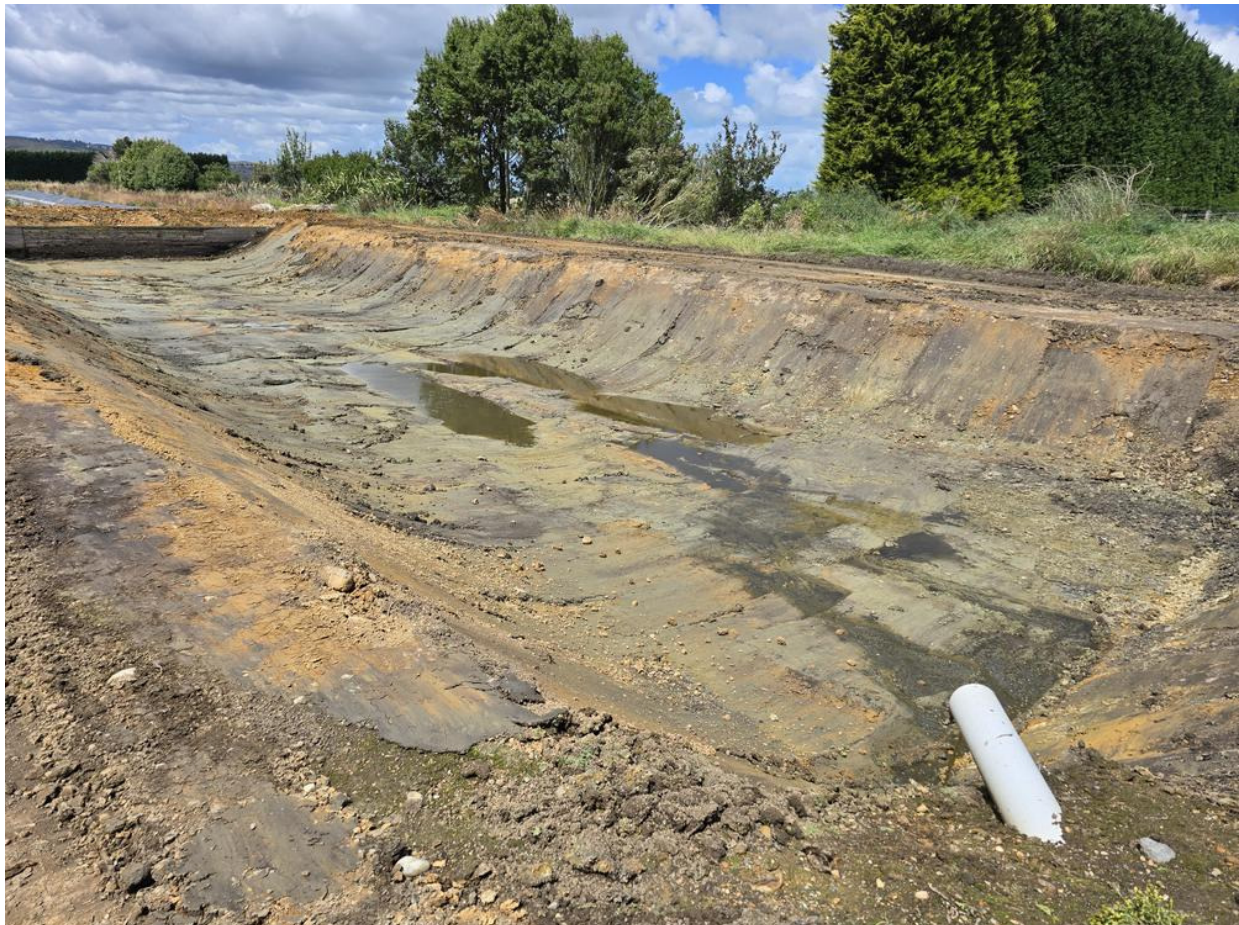
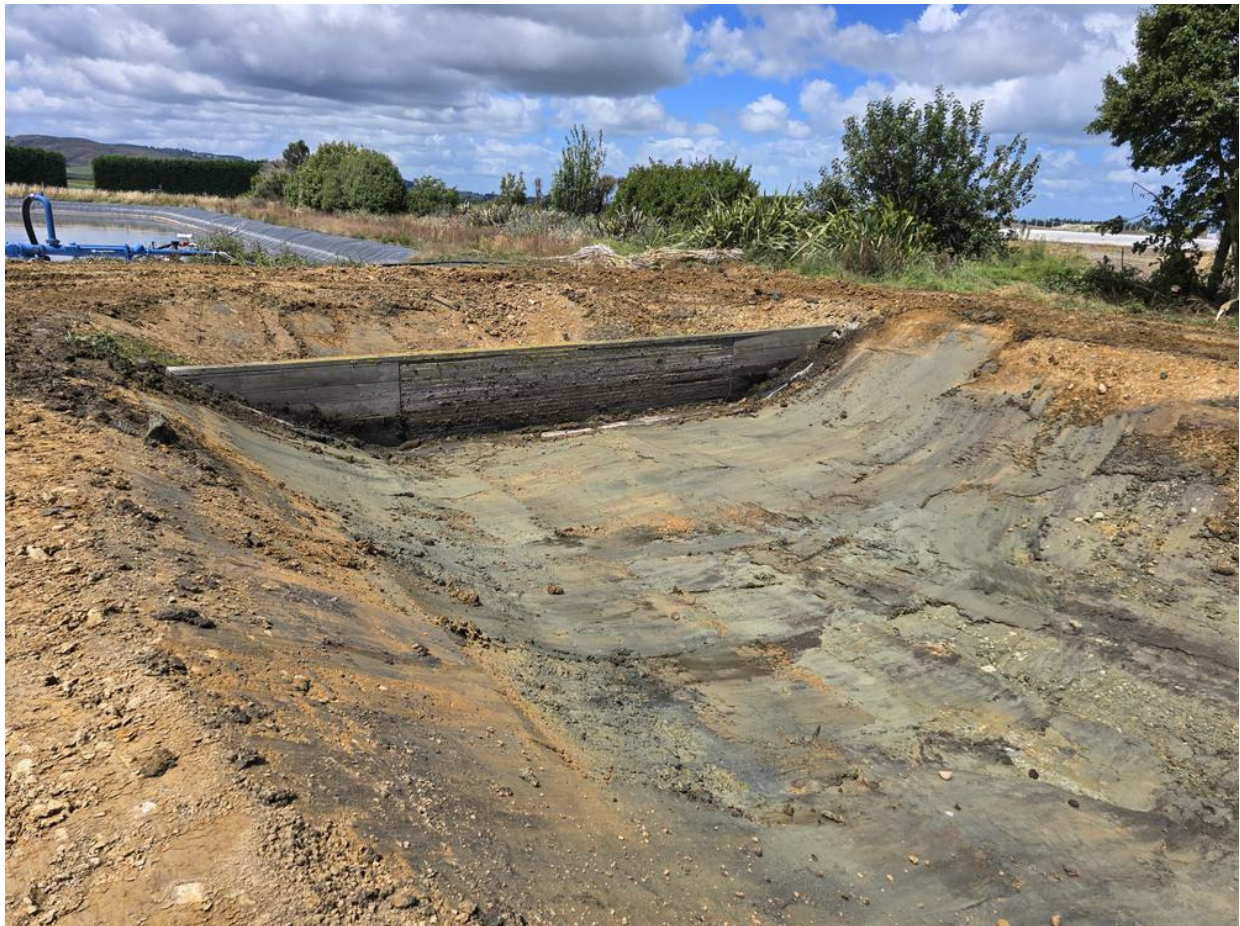
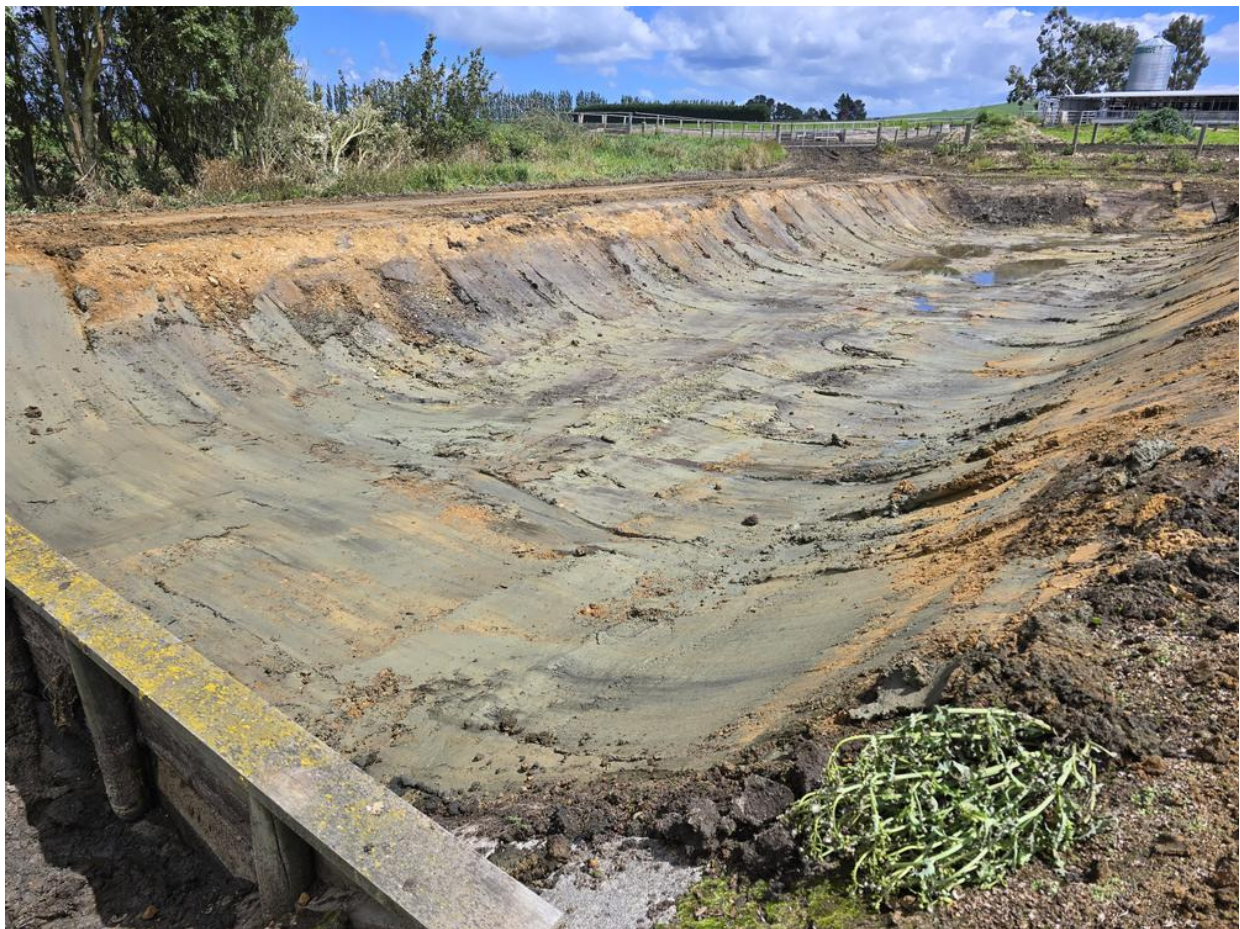
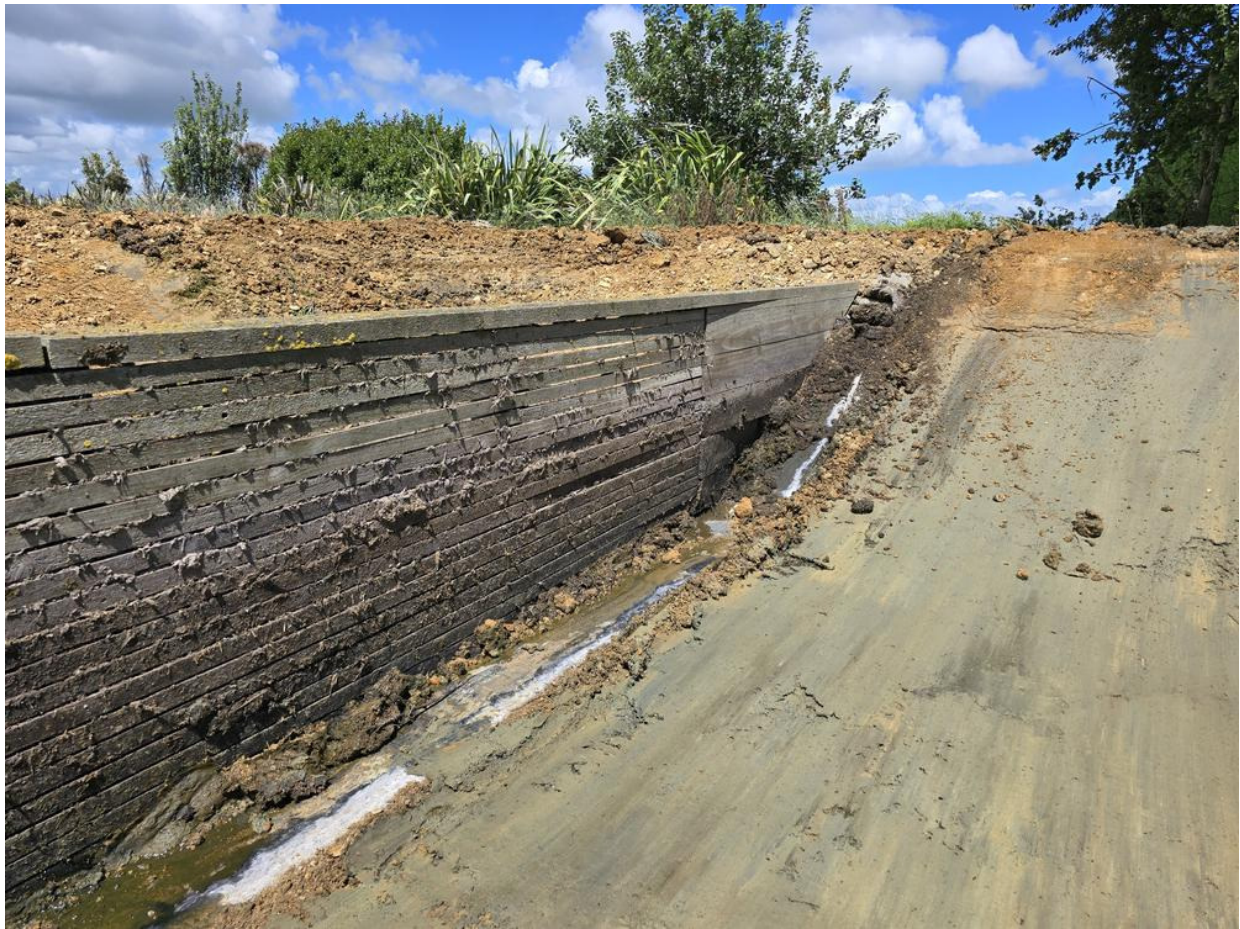
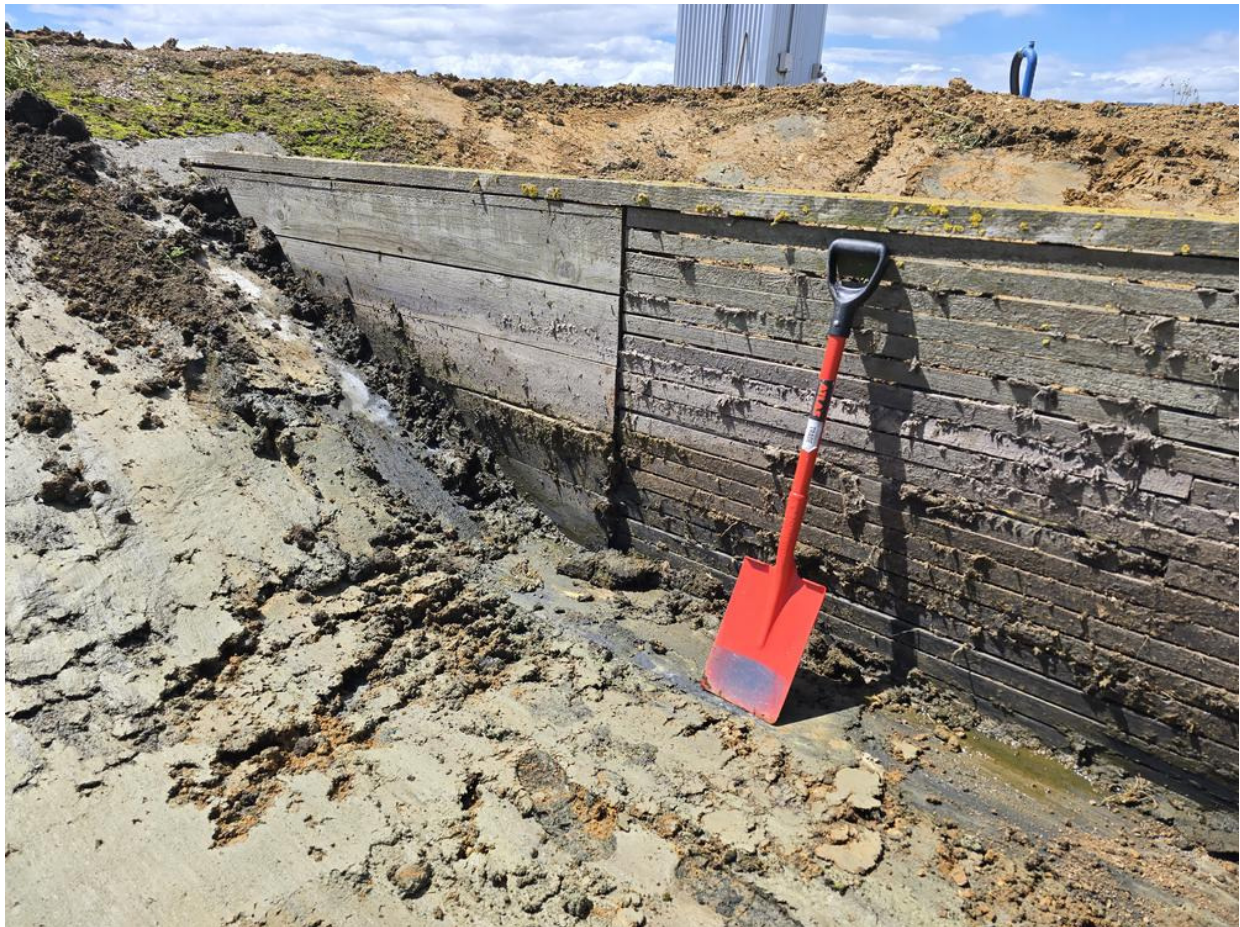
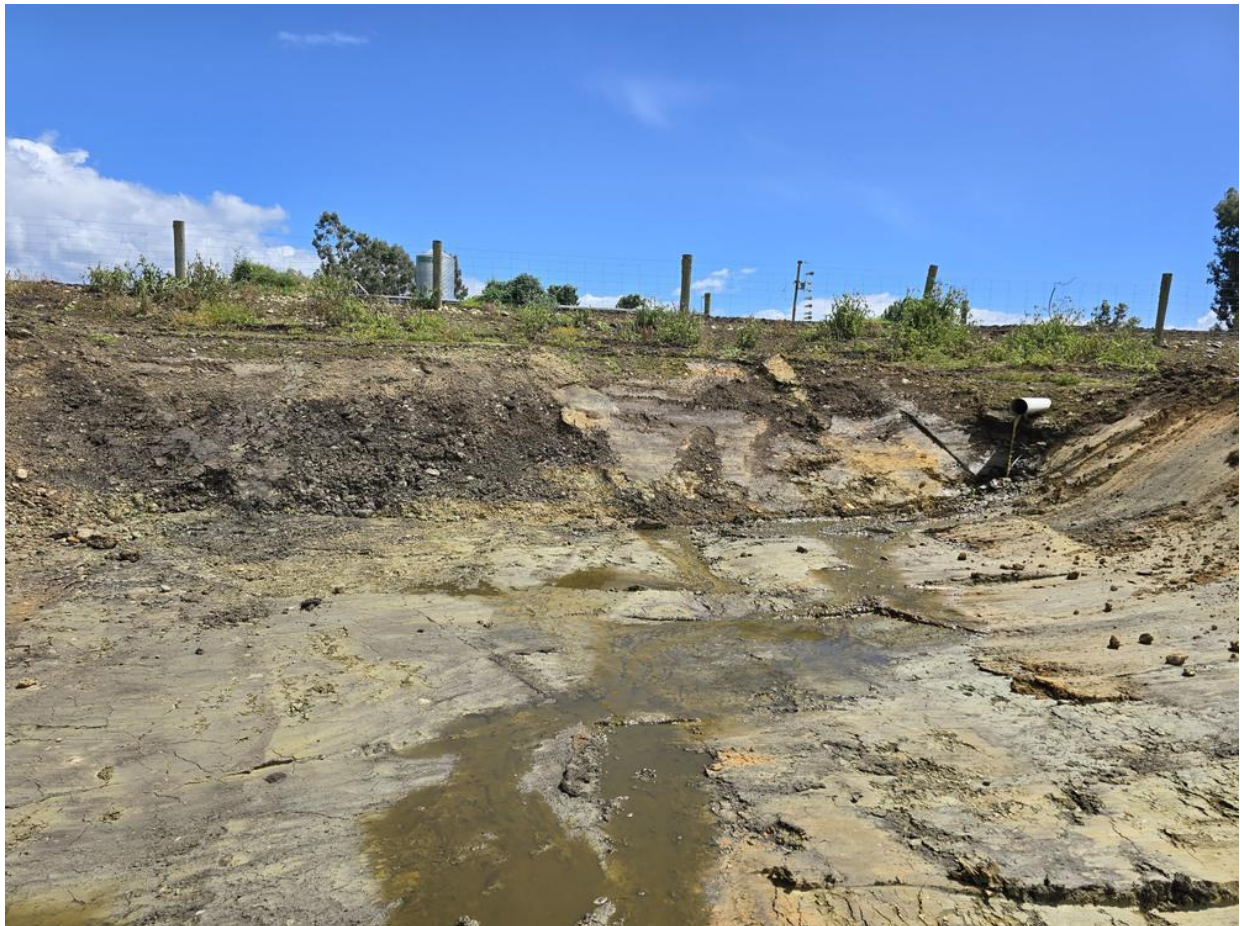
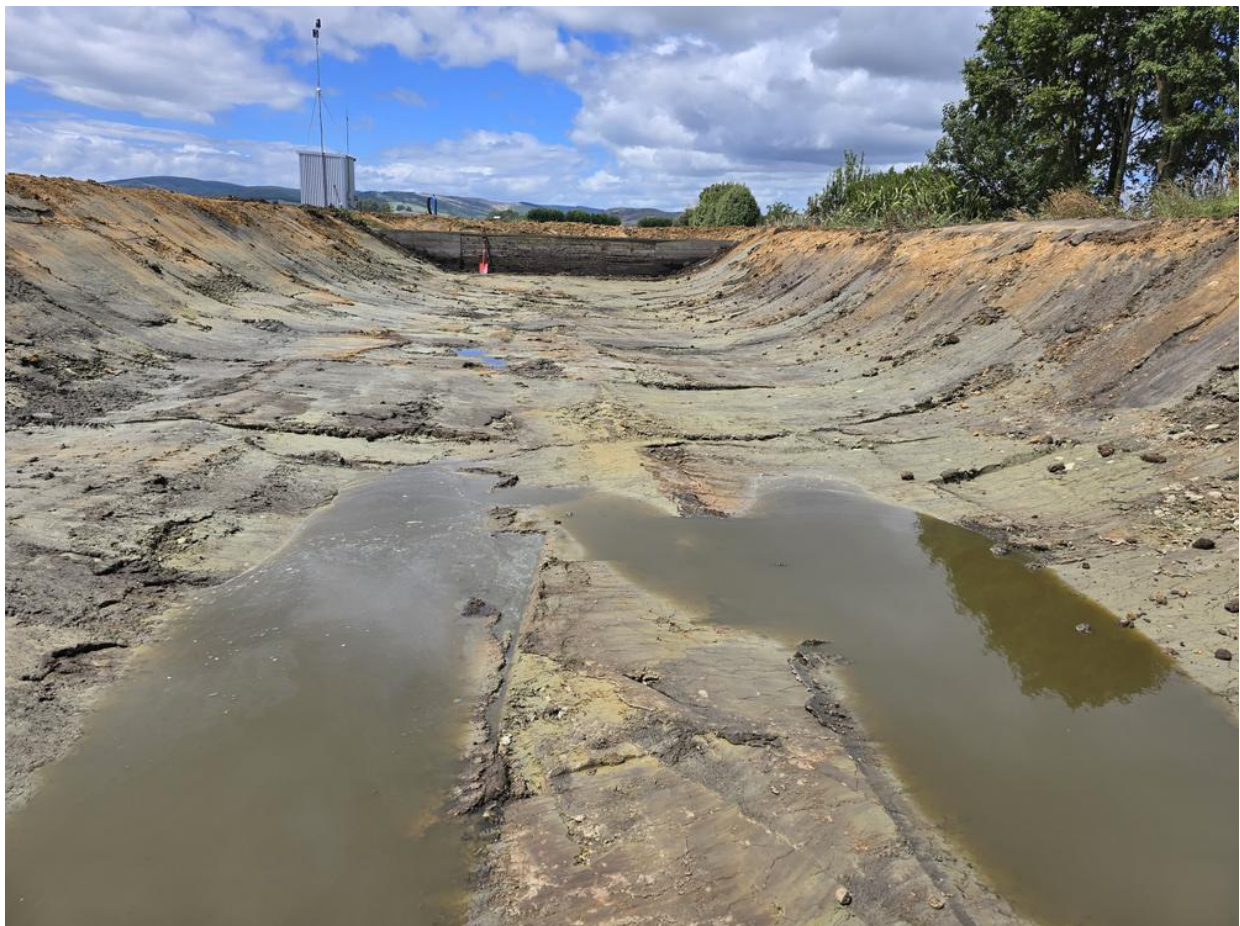
Figure 2 South sludge bed.

Figure 3 South sludge bed.

Figure 4 South sludge bed.

Figure 5 South sludge bed.

Figure 6 South sludge bed.

Figure 7 South sludge bed.

Figure 8 South sludge bed.

Figure 9 South sludge bed.

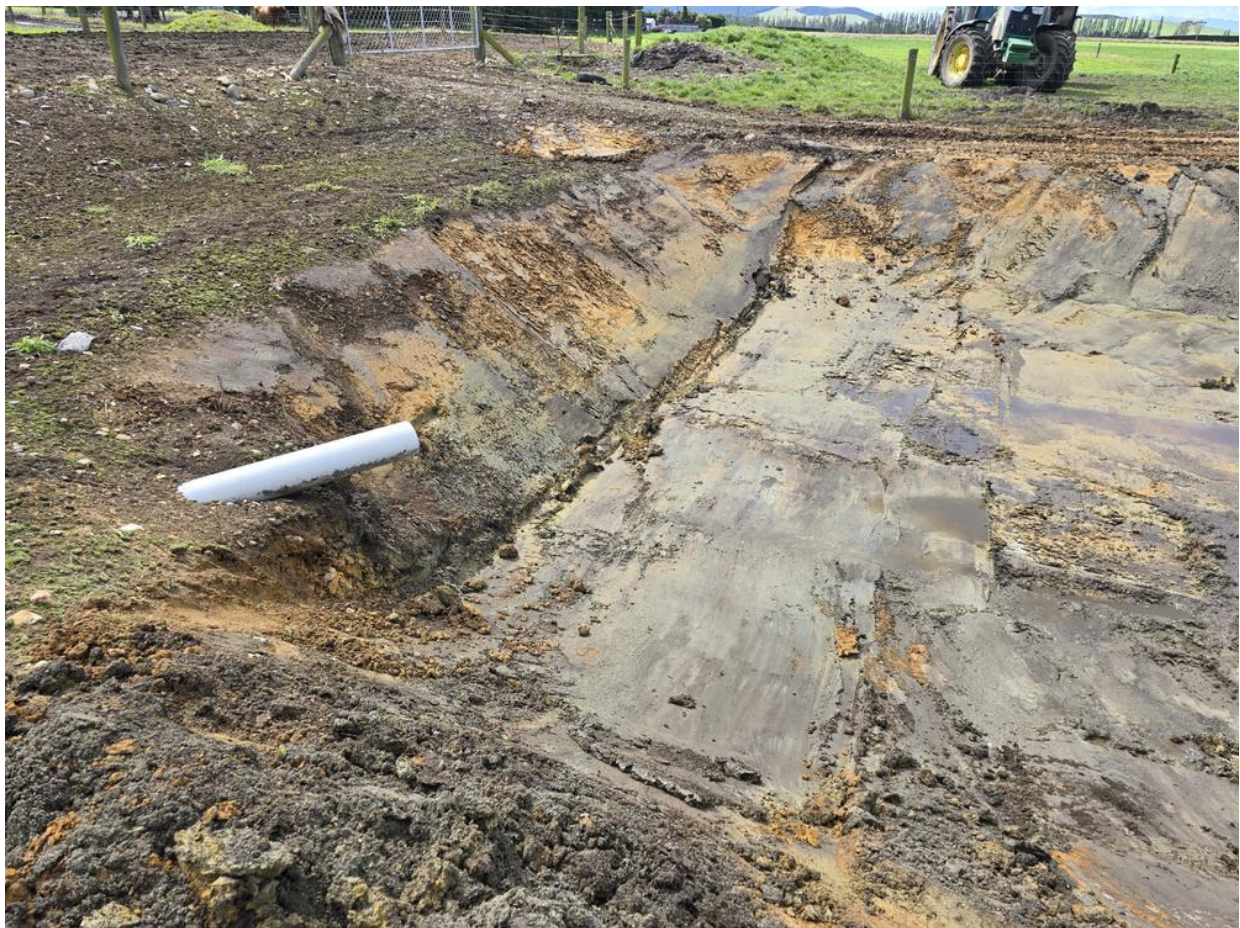
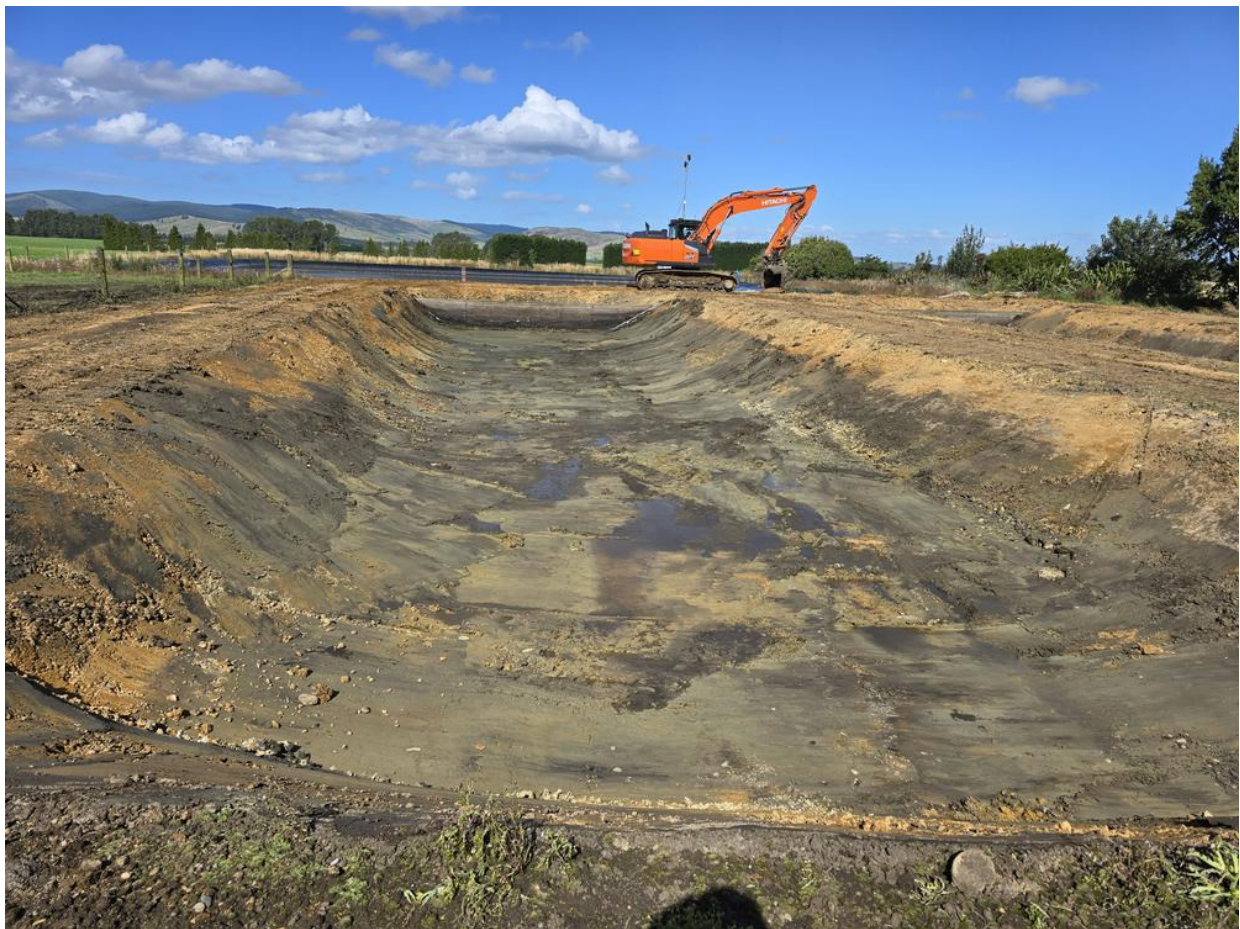
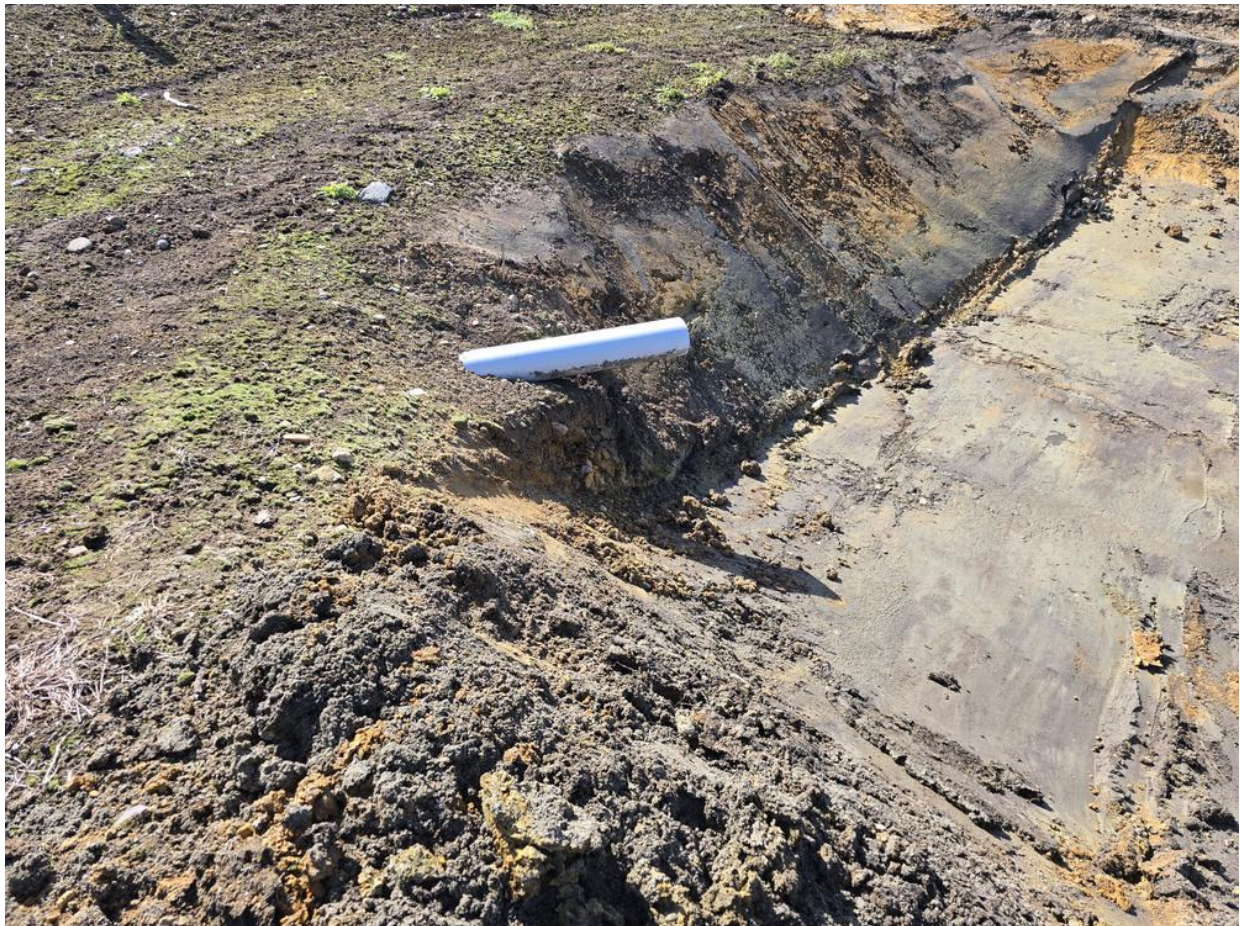
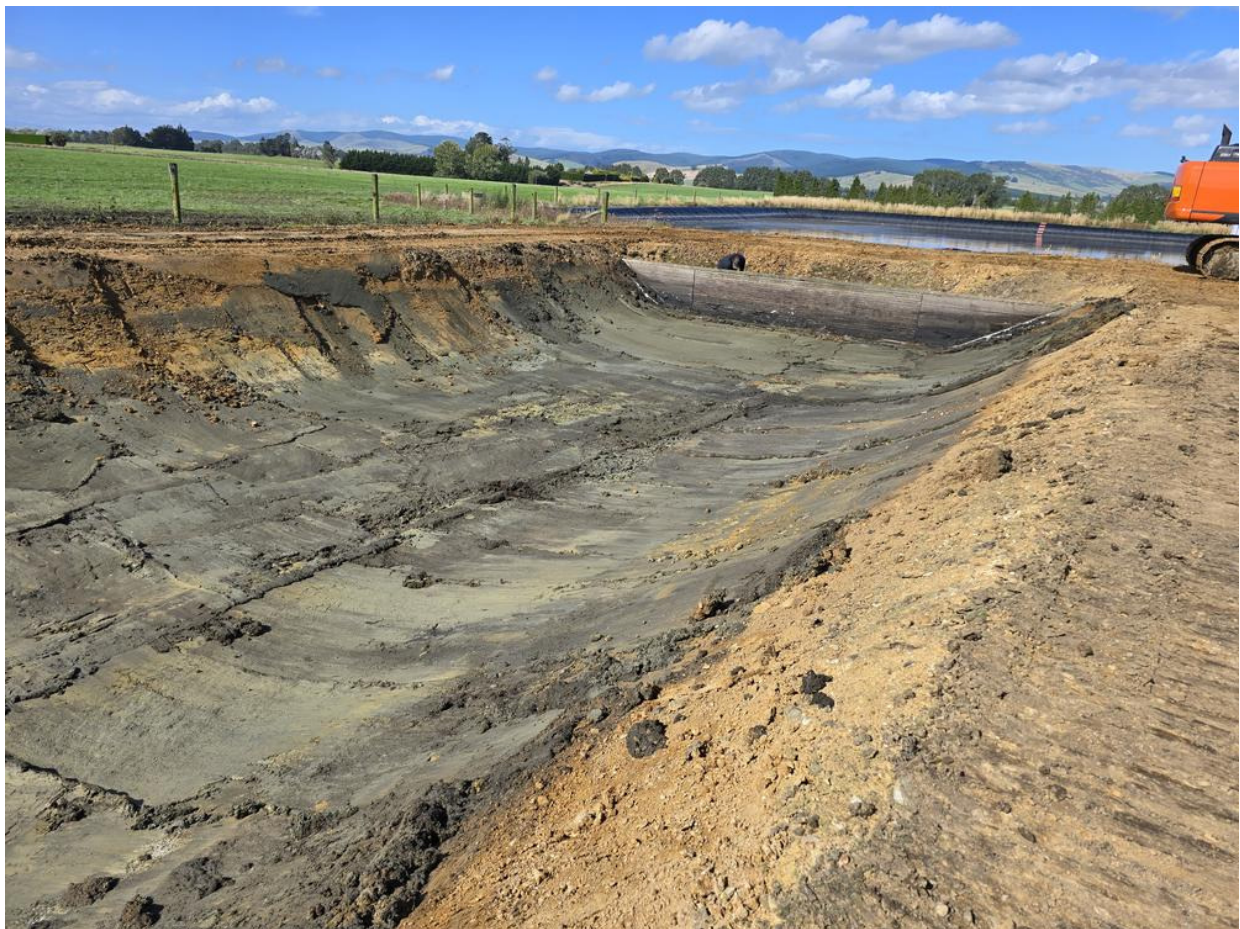
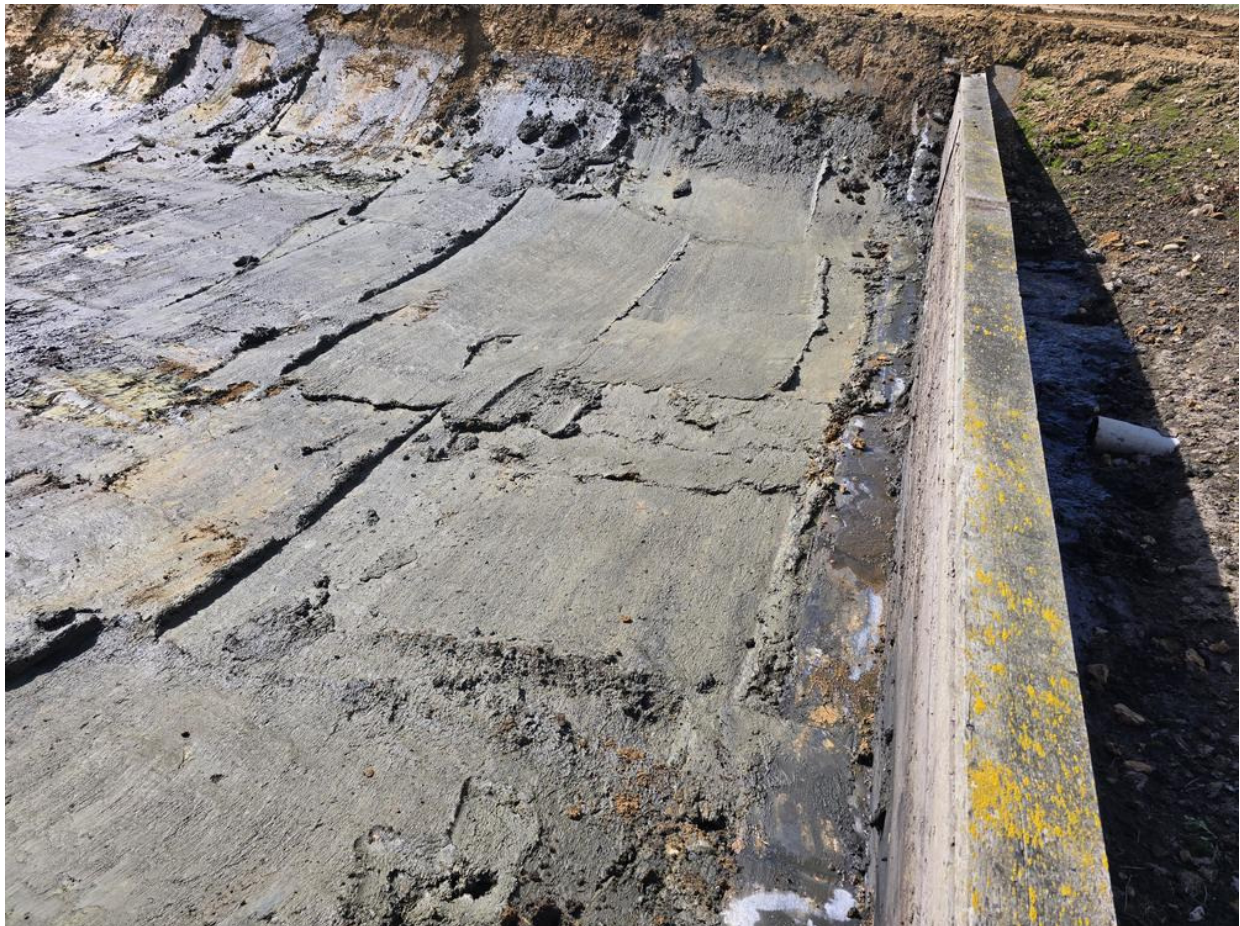
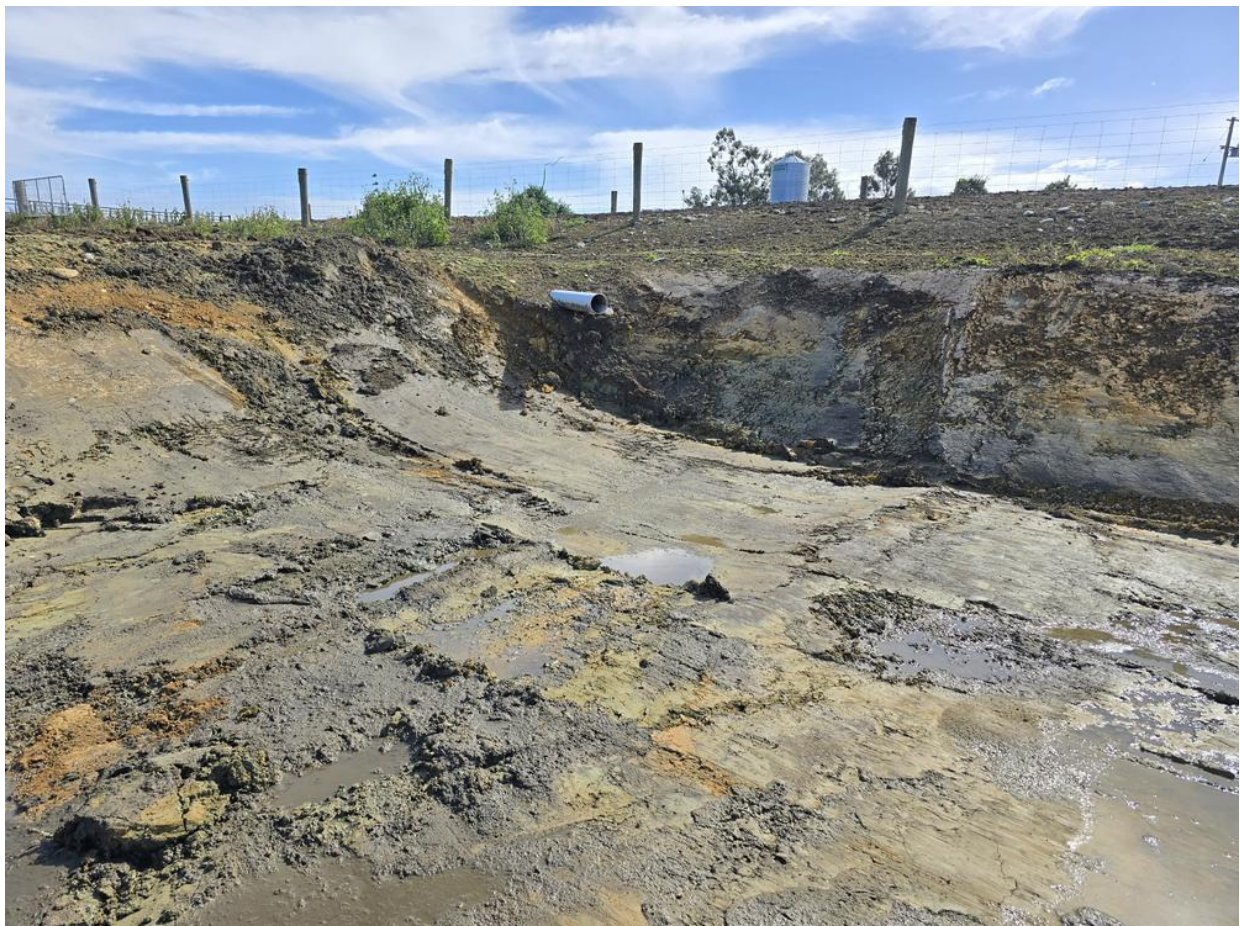
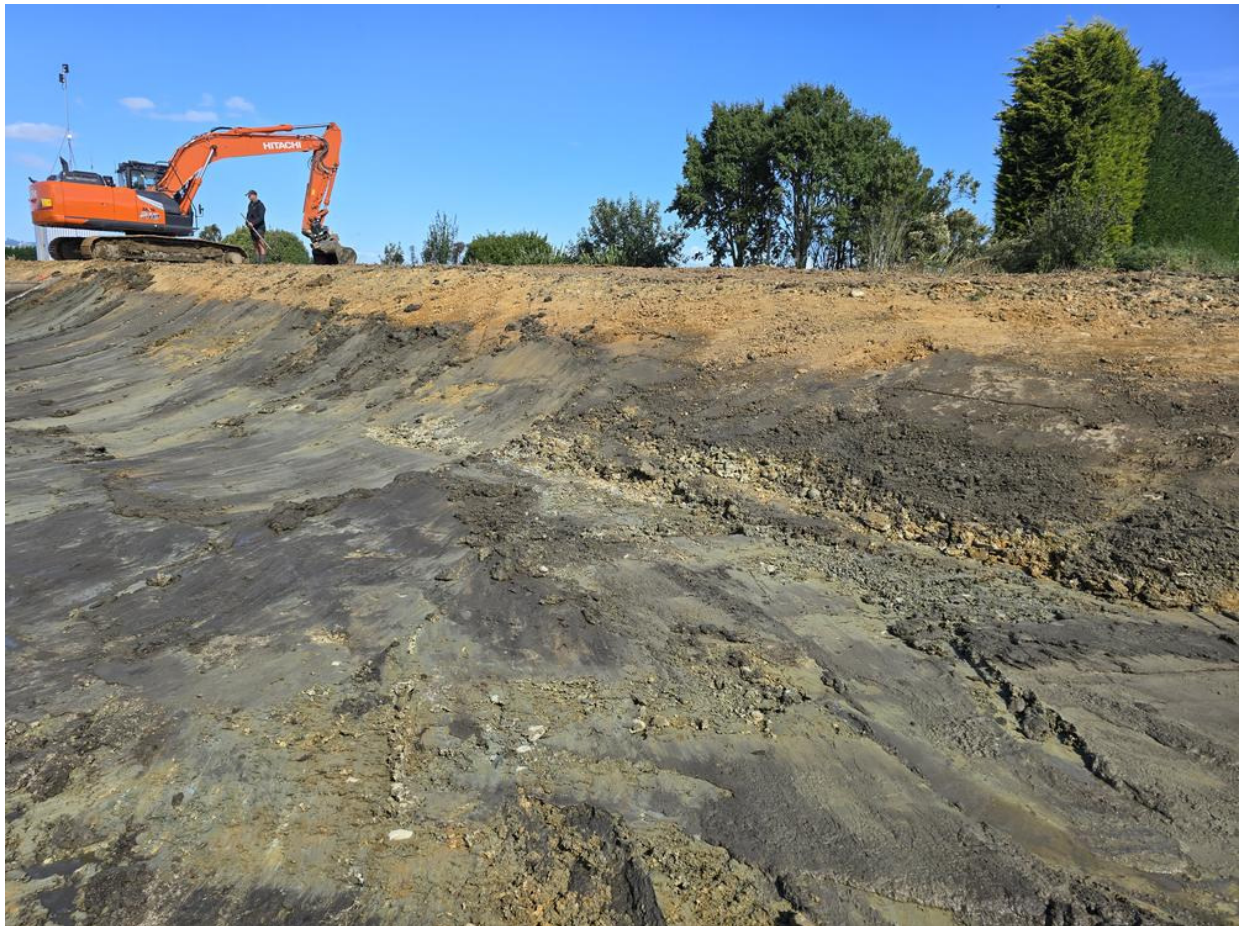
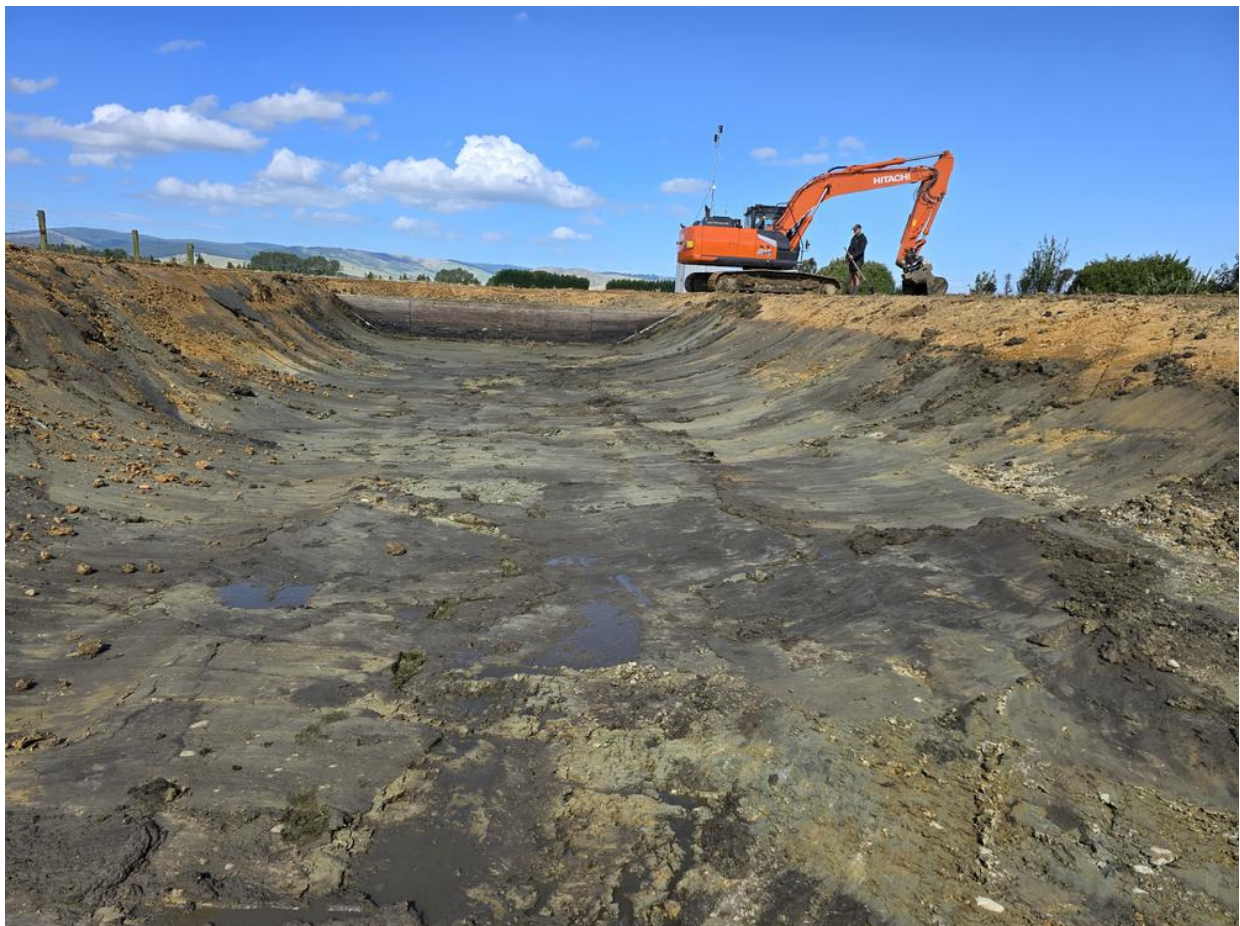
Figure 10 North sludge bed.

Figure 11 North sludge bed.

Figure 12 North sludge bed.

Figure 13 North sludge bed.

Figure 14 North sludge bed.

Figure 15 North sludge bed.

Figure 16 North sludge bed.

Figure 17 North sludge bed.
