**BEFORE THE A COMMISSIONER APPOINTED
BY THE SOUTHLAND REGIONAL COUNCIL**

IN THE MATTER of resource consents to occupy the Coastal Marine
Area with a tide gate and weir and to dam and divert
water

**BRIEF OF EVIDENCE OF COLIN SHEN YOUNG
16 August 2024**

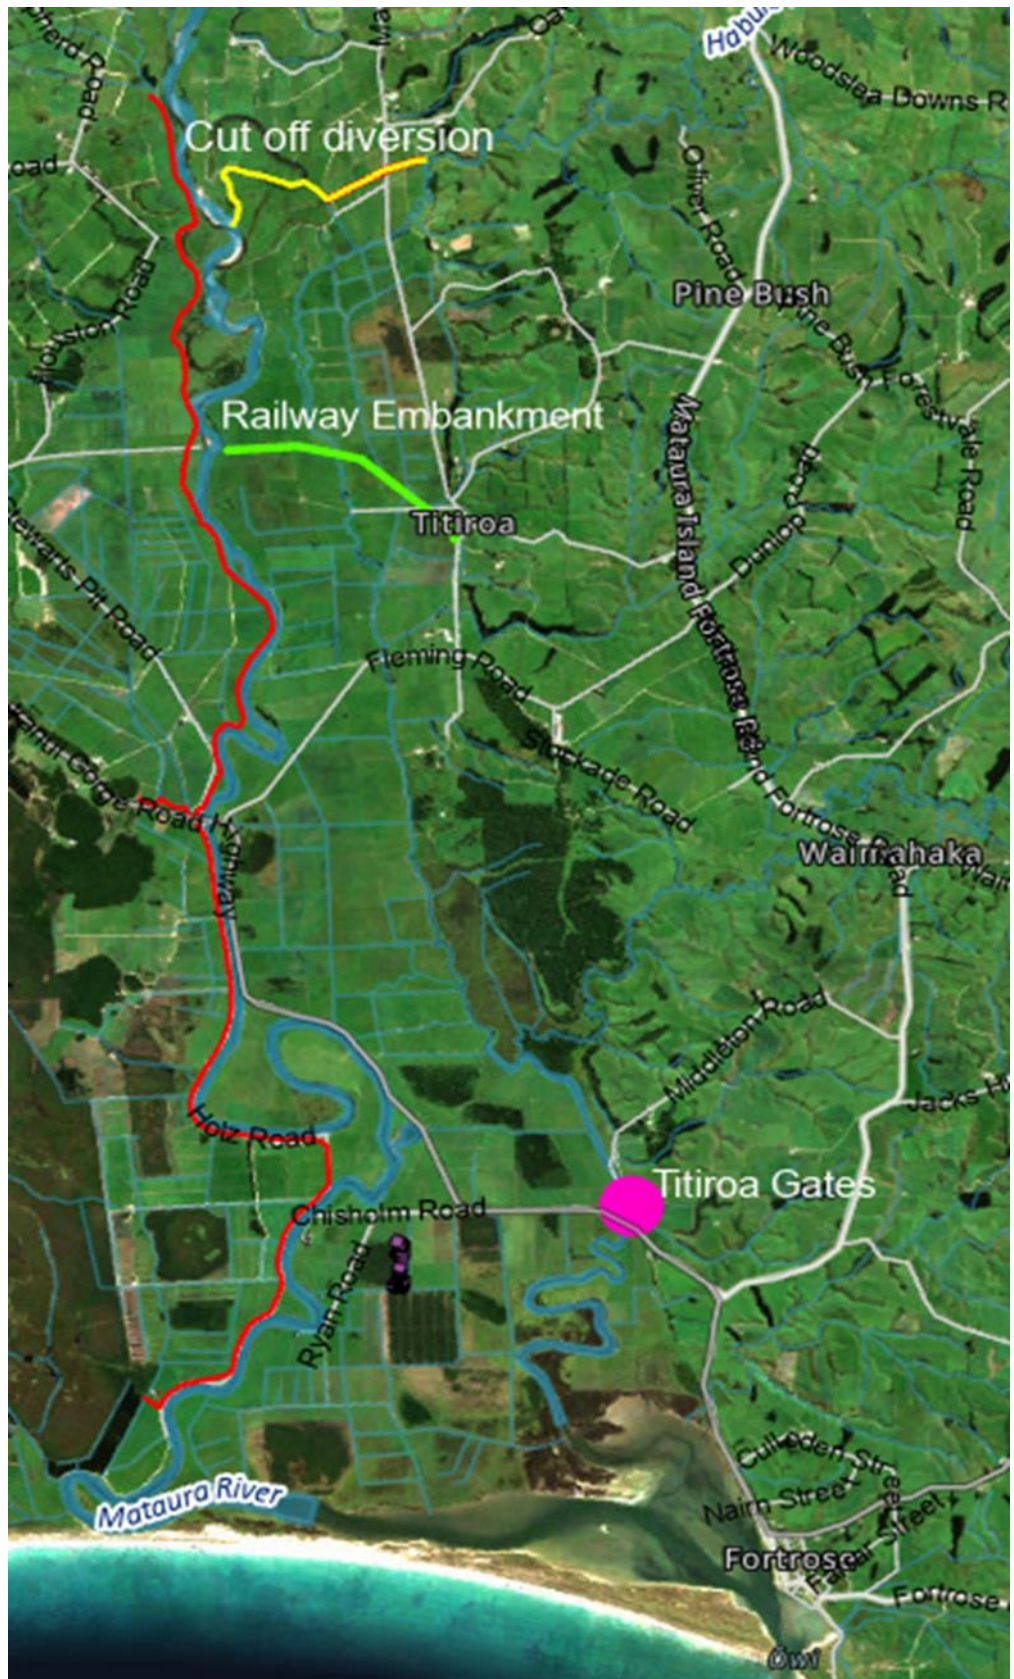
Appendix 1
Lower Mataura Floodway

7. The tide gates and weir are part of the Lower Mataura Catchment Flood Scheme, the extent of which is shown in Appendix 1. The gates are in the Titiroa Stream Catchment but perform functions associated with the wider Mataura River Catchment.

9. Based on my observations over nearly 40 years, the gates control the water table up to around the old railway embankment, about 7.3km from the application site and shown on Mr Connor's Appendix 1. This is higher in the catchment than Mr. Gardner models to assess the impact of the gate removal.

12. In addition to the matters Mr Connor describes, I have been asked to explain the cut-off diversion between the Titiroa Stream and Mataura River, approximately 9.7km from the gates and shown on Appendix 1 to Mr Connor's evidence. The cut-off is on the Mataura floodway and is an artificial channel.
